The Chehalis Basin Salmon Habitat Restoration and Preservation Strategy for WRIA 22 and 23

John M. Kliem and Deborah A. Holden
Creative Community Solutions, Inc.
6/30/2011

Grays Harbor County Lead Entity
Habitat Work Group

Updated June 30, 2011

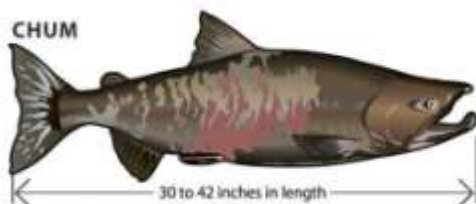
Life History Fall Chum Salmon (Kuttel 2002)

Chum enter rivers at the slightest increase instream flow, but late in the spawning season high flows are not essential. Chum are strong swimmers, but not leapers. They

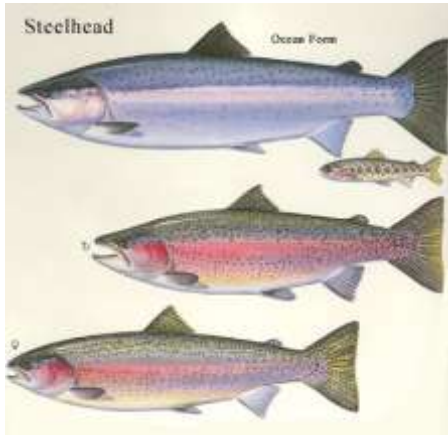
Life History Winter Steelhead Trout (Kuttel 2002)

Adult winter steelhead generally enter freshwater from November through March. Spawning usually takes place within four months of freshwater entry. The majority of returning adult steelhead are three to four years of age. These fish typically display three distinct life histories:
