# **Hoquiam Drainage - Barrier Inventory Results**

# WRIA 22 Fish Passage Inventory

Mason Conservation District

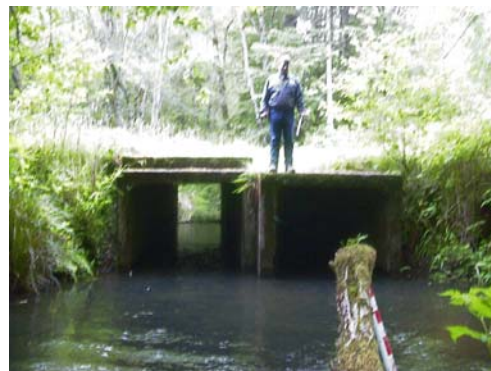
Originally thought culvert had tidal influence, but found beaver dam on downstream check. Culvert data will be forwarded to WDFW for evaluation of multiple pipe sites..

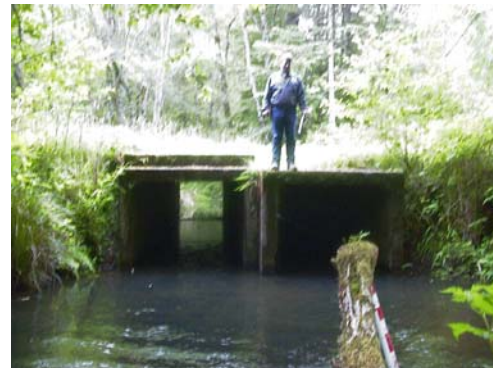
Beaver dam downstream impounding water - originally thought culvert had tidal influence, but found beaver dam on downstream check. Culvert will need to be analyzed by WDFW crew for Level B - we cannot perform level b analysis on multiple culvert sites.

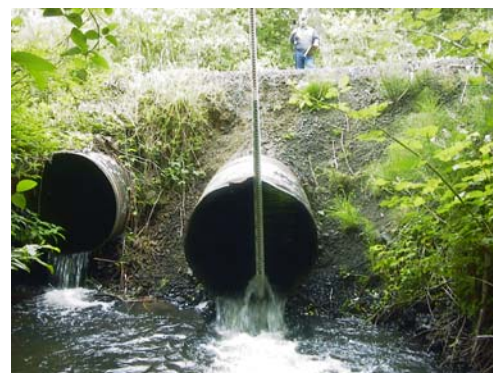
Juvenile coho observed in pool on upstream end of culvert. Right bank has private residence.

Review Date:	6/23/2003
Field Crew:	Glore/Peterson
Barrier	Yes
Passability (%)	67
Method	LA
Repair Status	UD
Problem	outfall drop

Culvert 1.2 is on right bank.

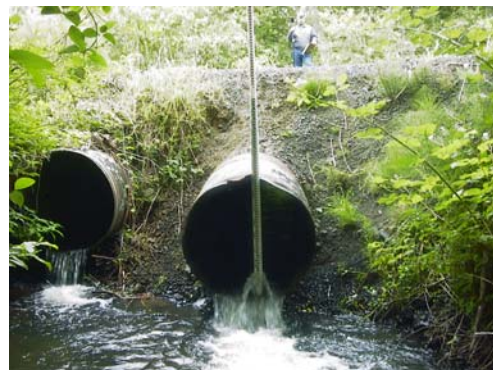
Culvert 2.2 is on left bank.

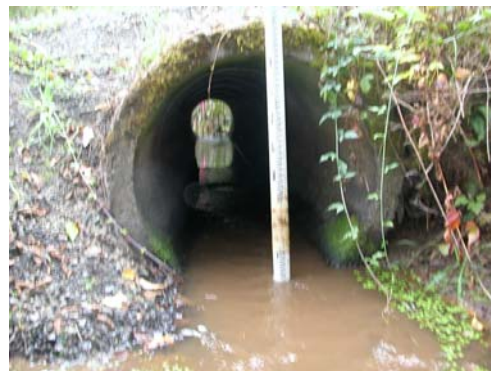
Review Date:	6/23/2003
Field Crew:	Glore/Peterson
Barrier	Yes
Passability (%)	67
Method	LB
Repair Status	RR
Problem	depth

4 inch x 4 inch rebar gate over upstream end. Level B evaluation indicates that pipe is a depth barrier.

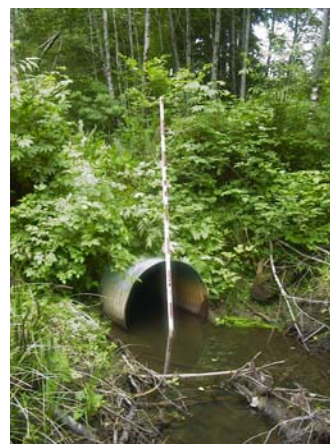
Overflow hole in top of pipe.

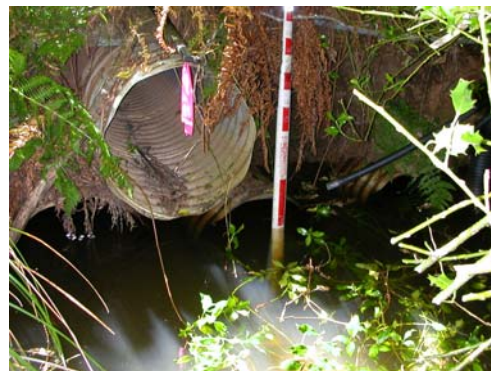
Review Date:	6/23/2003
Field Crew:	Glore/Peterson
Barrier	Yes
Passability (%)	67
Method	LA
Repair Status	UD
Problem	slope

Downstream control and toe not available due to wetland influence directly downstream of pipe. Upstream bank is reinforced with concrete. Pipe 1.3 is located on left bank.

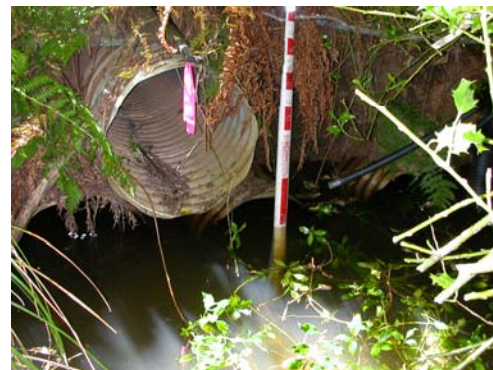
Pipe 2.3 is the center pipe.

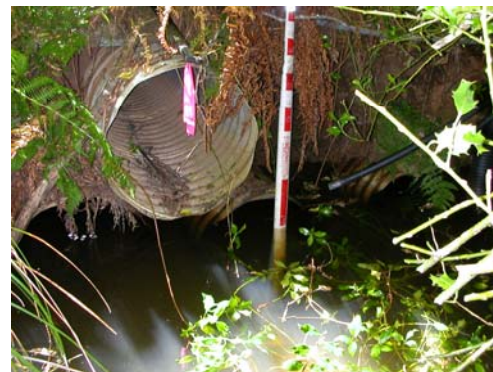
Pipe 3.3 is located on right bank.

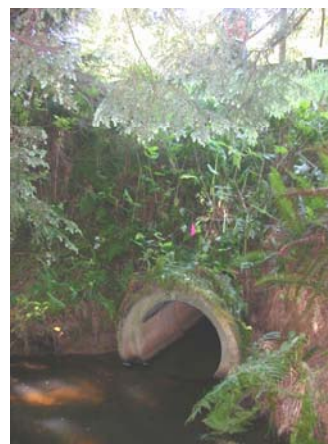
Sediments in pipe are fines, last 5 meters angled to left bank. Upstream end of pipe is box (106 span/125 rise) cast in place concrete. Level B not applicable due to grade break with culvert.

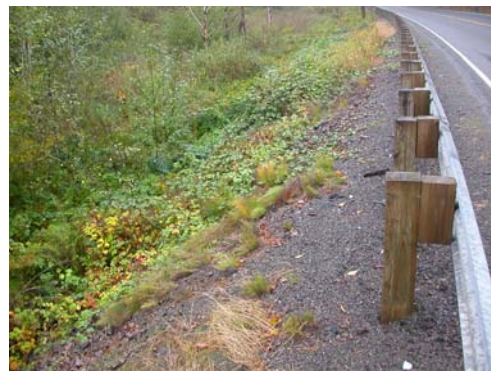
Unable to locate downstream end of culvert, probably buried. Not able to complete level A evaluation.

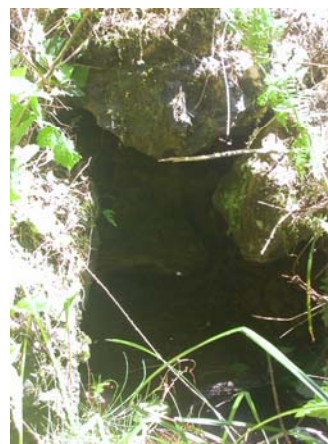
Review Date: 6/25/2003  
Field Crew: Glore/Peterson  
Barrier: Yes  
Passability (%): 33  
Method: LA  
Repair Status: UD  
Problem: slope

Downstream end buried in fill from road grade, but still semi-accessible. No measurable plunge pool or toe.

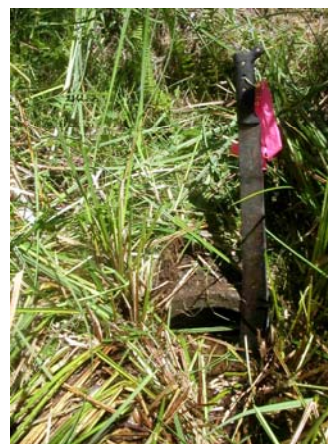
Review Date:	6/25/2003
Field Crew:	Glore/Peterson
Barrier	Yes
Passability (%)	33
Method	LA
Repair Status	UD
Problem	slope

Downstream end partially buried, less than 10 cm of passable pipe. Plunge pool not accessible because downside end is buried.

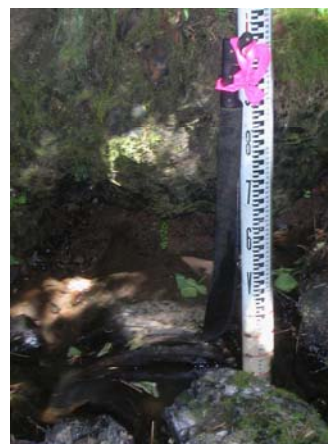
Review Date: 6/25/2003  
Field Crew: Glore/Peterson  
Barrier: Yes  
Passability (%): 67  
Method: LA  
Repair Status: UD  
Problem: slope

Downstream end is submerged, making plunge pool and toe impossible due to backwater. Upstream end of pipe is CST, Downstream end of pipe is PCC.

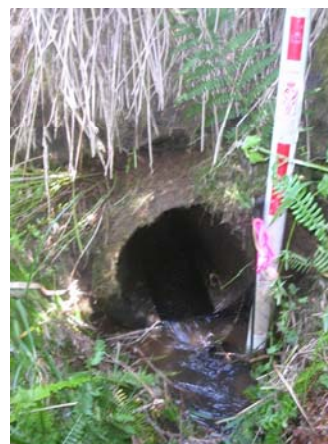
Bedrock cascade 5m DS of pipe (approx. 2 vertical meters) into subterranean flow. Emerges 3-8m DS in 3 separate flows. Pipe seems to be set on LB of natural stream bed. Level B not applicable due to DS subsurface flows.

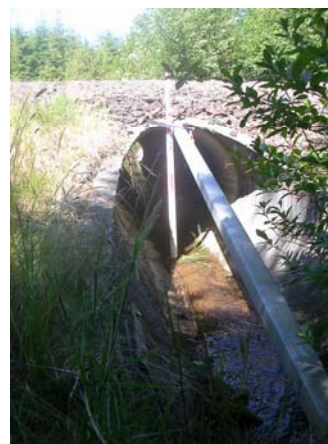
Review Date: 6/25/2003  
Field Crew: Glore/Peterson  
Barrier: Yes  
Passability (%): 67  
Method: LA  
Repair Status: UD  
Problem: slope

Plunge pool measurements unavailable due to wetland influence downstream of culvert.

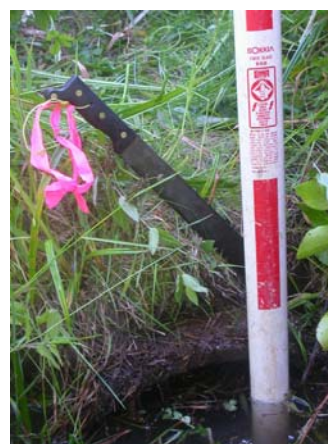
Review Date: 6/25/2003  
Field Crew: Glore/Peterson  
Barrier: Yes  
Passability (%): 67  
Method: LA  
Repair Status: UD  
Problem: slope

Downstream end of pipe submerged, no measurable plunge pool.

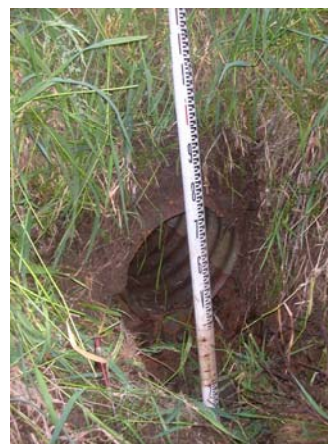
Review Date:	6/26/2003
Field Crew:	Glore/Peterson
Barrier	Yes
Passability (%)	33
Method	LA
Repair Status	UD
Problem	outfall drop, slope

Upstream bottom of pipe rusted out.

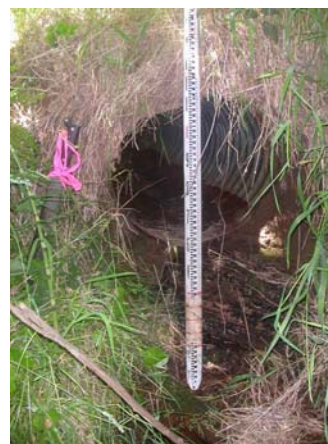
Pipe has failed, flow is subterranean through road grade 5 meters upstream from pipe.

Review Date:	6/26/2003
Field Crew:	Glore/Peterson
Barrier	Yes
Passability (%)	0
Method	LA
Repair Status	UD
Problem	outfall drop, slope

Plunge pool measurements unavailable because pipe has failed and is no longer passing water.

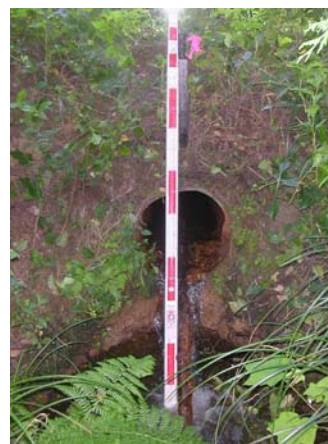
Review Date: 6/26/2003  
Field Crew: Glore/Peterson  
Barrier: Yes  
Passability (%): 33  
Method: LA  
Repair Status: UD  
Problem: outfall drop, slope

Upstream end of culvert crushed. Wetland downstream prevents toe measurements. Culvert is sloped inversely.

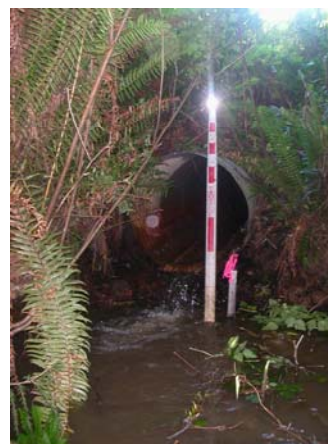
Wetland immediately downstream of plunge pool.

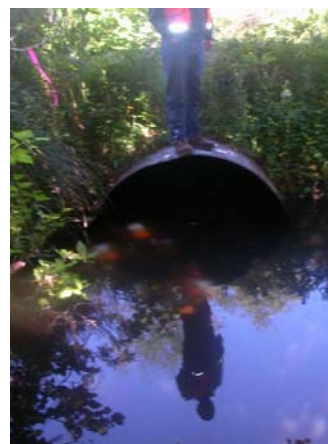
No plunge pool or stream width measurements due to wetland influences. Level B not applicable due to lack of downstream control.

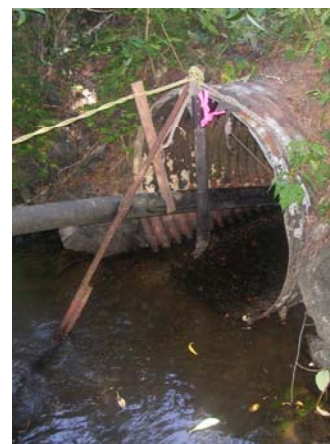
2 inch PVC pipe running through culvert.

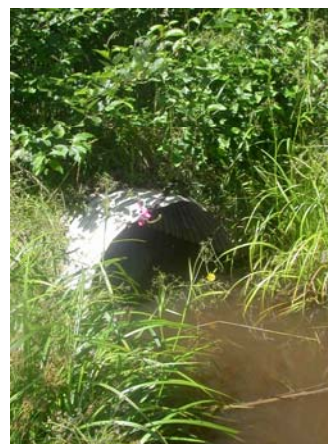
No plunge pool or stream width measurements due to wetland influences. Level B not applicable due to lack of downstream control.

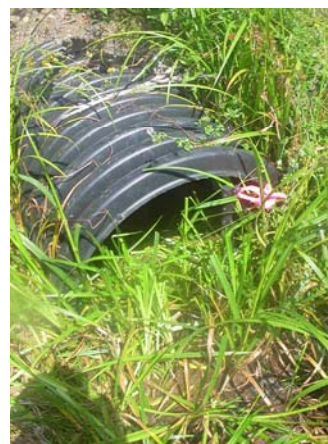
No plunge pool or stream width measurements due to wetland influences. Level B not applicable due to lack of downstream control.

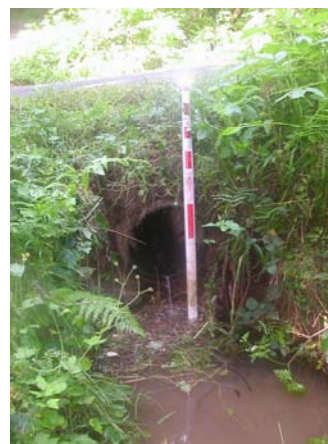
Toe measurement unattainable due to confluence immediately downstream of plunge pool, toe is near 0.60 meters.

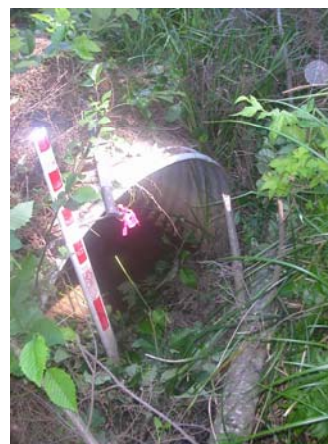
No plunge pool or stream width measurements due to wetland influences. Level B not applicable due to lack of downstream control.

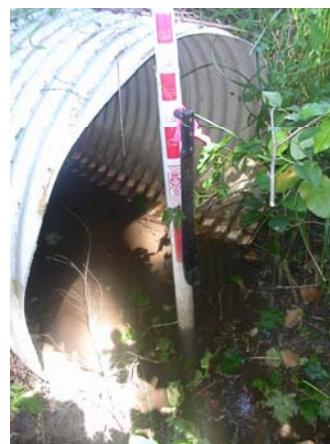
No plunge pool or stream width measurements due to wetland influences. Level B not applicable due to lack of downstream control.

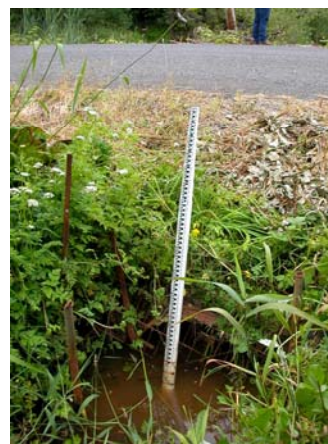
Review Date: 7/7/2003  
Field Crew: Glore/Peterson  
Barrier: Yes  
Passability (%): 0  
Method: LA  
Repair Status: UD  
Problem: slope

Culvert is impounding water with a vertical overflow intake upstream. Steel grate have been fastened to both ends. Large wetlands upstream and downstream.

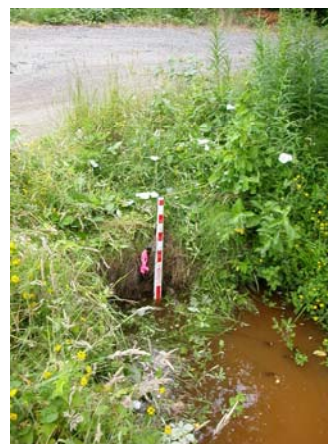
Level B not applicable due to lack of downstream control. Both ends of pipe are completely submerged with brackish water.

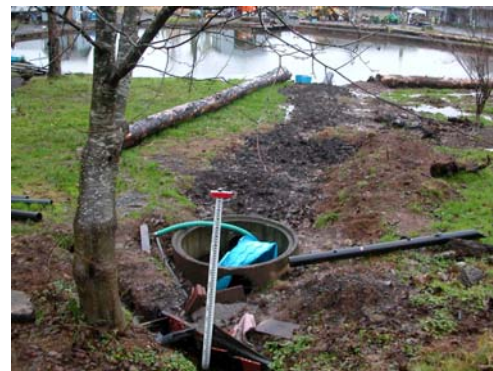
Water flows directly into private pond downstream, upstream has ditch delivery obscuring stream width measurements.

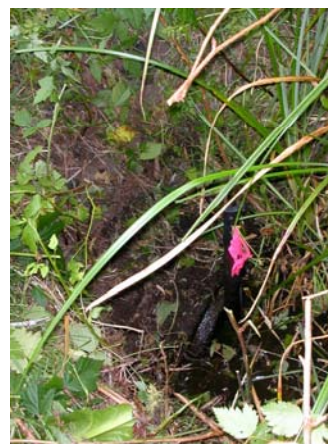
No plunge pool or stream width measurements due to wetland influences.

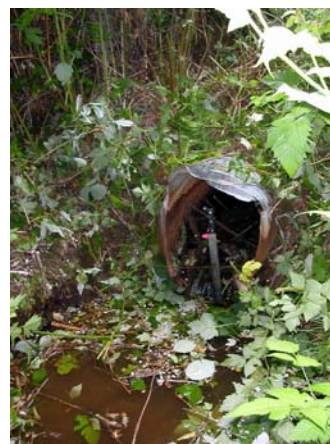
US end buried by massive beaver dam, DS end of culvert is deformed and choked with beaver debris. Unable to obtain level A measurements.

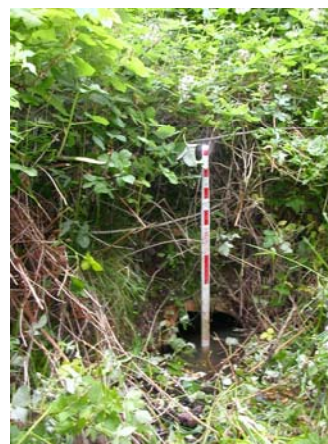
Could not locate upstream end of culvert due to wetland. Pipe is either buried by fill or submerged.

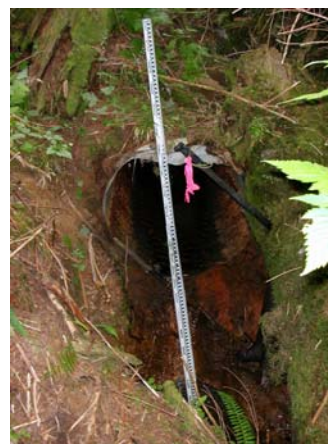
Debris pile downstream of pipe.

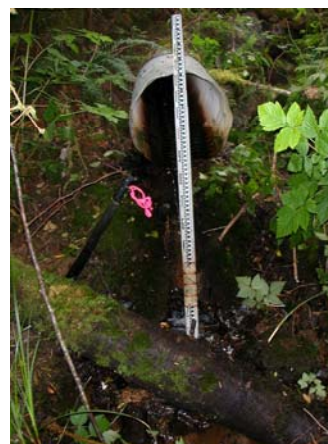
No plunge pool due to high gradient on downstream end of culvert.

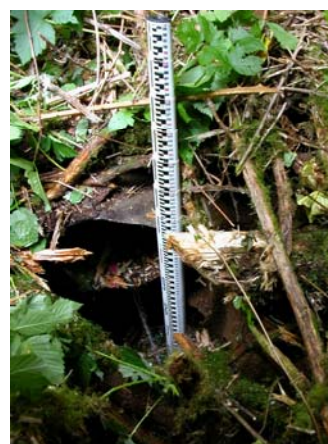
Debris pile downstream of pipe.

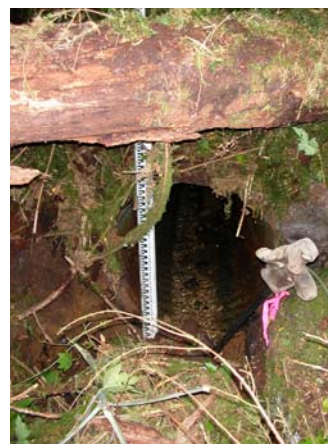
Review Date: 7/7/2003  
Field Crew: Glore/Peterson  
Barrier: Yes  
Passability (%): 33  
Method: LA  
Repair Status: UD  
Problem: outfall drop, slope

Debris pile downstream of pipe.

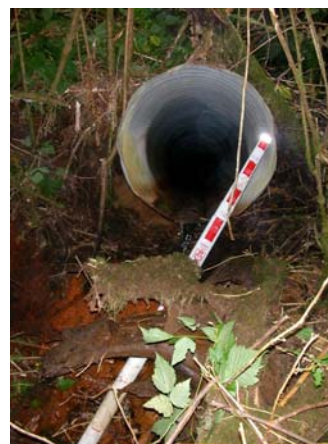
Review Date:	7/7/2003
Field Crew:	Glore/Peterson
Barrier	Yes
Passability (%)	33
Method	LA
Repair Status	UD
Problem	outfall drop, slope

Sequencer:	1.1
Shape	RND
Material	CST
Span (m)	0.64
Rise (m)	0.64
Length (m)	27.88
Slope (%)	11.20
Bed Material	No
Outfall Drop (m)	0.95
WDIC (m)	0.02
Apron	No
Fill Depth (m)	8.00
Tidegate	No

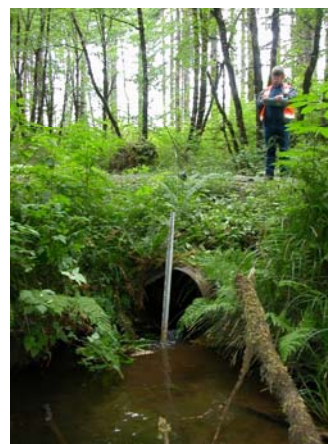
Review Date: 7/8/2003  
Field Crew: Glore/Peterson  
Barrier: Yes  
Passability (%): 67  
Method: LB  
Repair Status: UD  
Problem: velocity

Water exits plunge pool on left bank and continues to run parallel with road. Substrate is hard pan aggregate, made up of gravel and fines.

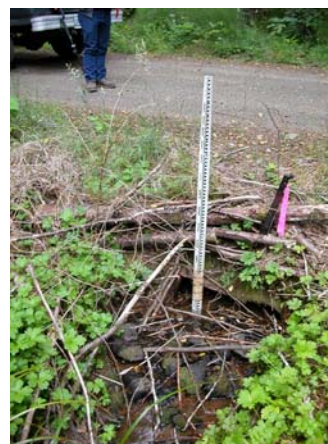
Downstream end of pipe smashed. Culvert is sloped inversely.

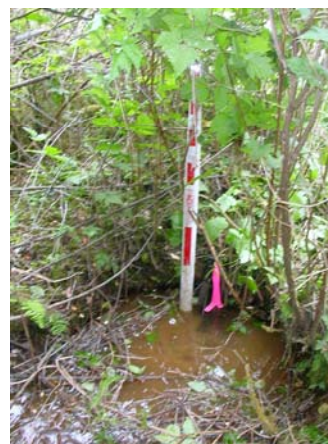
Level B not applicable due to lack of downstream control.

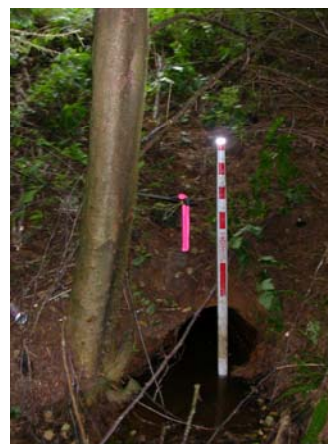
Review Date:	7/8/2003
Field Crew:	Glore/Peterson
Barrier	Yes
Passability (%)	67
Method	LA
Repair Status	UD
Problem	slope

Sequencer:	1.1
Shape	RND
Material	CST
Span (m)	0.65
Rise (m)	0.65
Length (m)	10.91
Slope (%)	2.66
Bed Material	No
Outfall Drop (m)	0.00
WDIC (m)	0.03
Apron	No
Fill Depth (m)	2.00
Tidegate	No

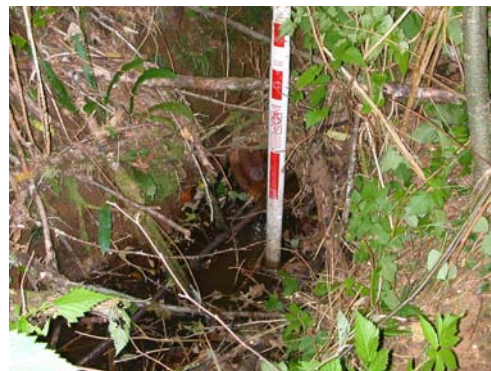
Review Date: 7/8/2003  
Field Crew: Glore/Peterson  
Barrier: Yes  
Passability (%): 33  
Method: LA  
Repair Status: UD  
Problem: slope

Car parts scattered in plunge pool.

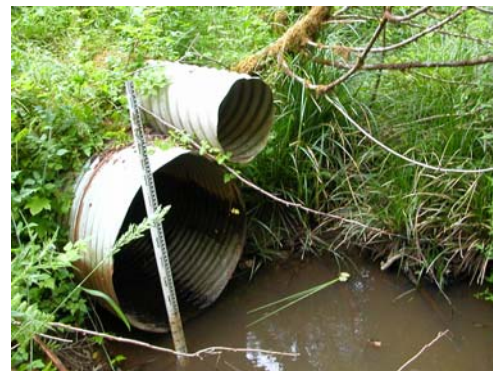
Review Date: 7/8/2003  
Field Crew: Glore/Peterson  
Barrier: Unk  
Passability (%):  
Method: LBNA  
Repair Status:  
Problem:

Overflow pipe above main culvert. Beaver dam 15 meters downstream. Level B not applicable due to lack of downstream control.

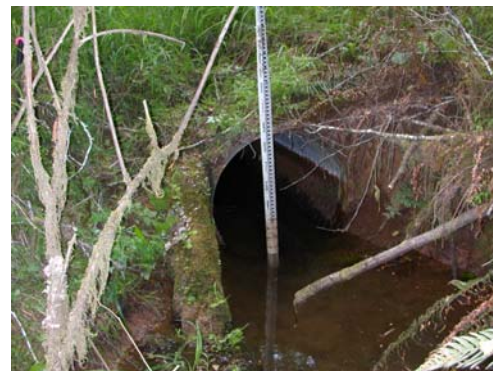
Review Date: 7/8/2003  
Field Crew: Glore/Peterson  
Barrier: Yes  
Passability (%): 67  
Method: LA  
Repair Status: UD  
Problem: slope

Stream flow is subterranean upstream, 1.2 vertical meter partial barrier encountered 20 meters downstream of culvert.

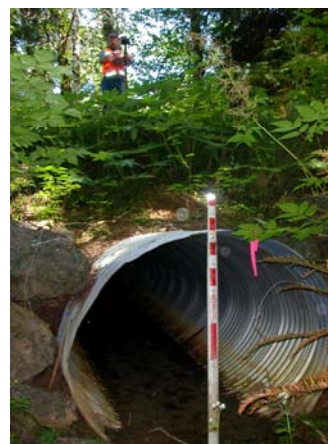
Review Date:	7/9/2003
Field Crew:	Glore/Peterson
Barrier	No
Passability (%)	100
Method	LA
Repair Status	OK
Problem

New culvert with no plunge pool. Juvenile coho caught in pools above and below culvert due to low flow conditions.

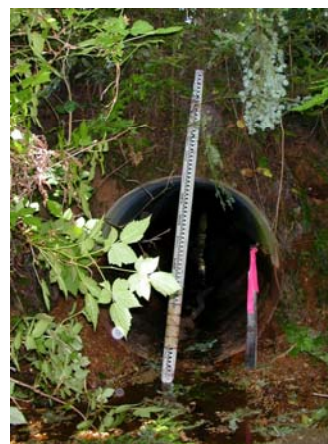
Review Date: 7/9/2003  
Field Crew: Glore/Peterson  
Barrier: Yes  
Passability (%): 67  
Method: LA  
Repair Status: UD  
Problem: slope

Wetlands upstream and downstream of site.  
Overflow pipe located above main culvert.

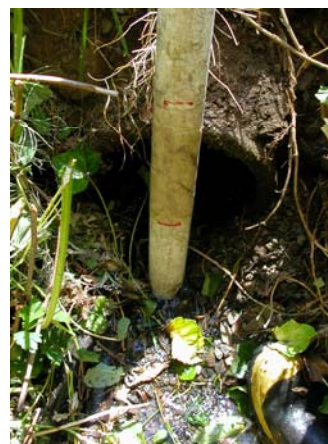
Review Date:	7/10/2003
Field Crew:	Glore/Peterson
Barrier	Yes
Passability (%)	67
Method	LA
Repair Status	UD
Problem	slope

Plunge pool measurements unavailable due to confluence immediately downstream of pipe.

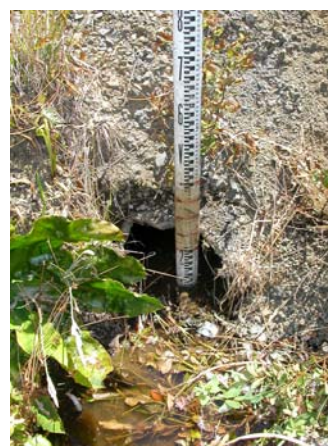
Downstream end of pipe is crushed.

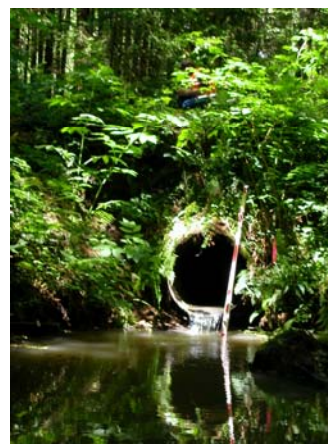
Review Date: 7/10/2003  
Field Crew: Glore/Peterson  
Barrier: Yes  
Passability (%): 67  
Method: LA  
Repair Status: UD  
Problem: slope

Old pipe is buried beneath functional culvert, visible on downstream end in plunge pool. Culvert is sloped inversely.

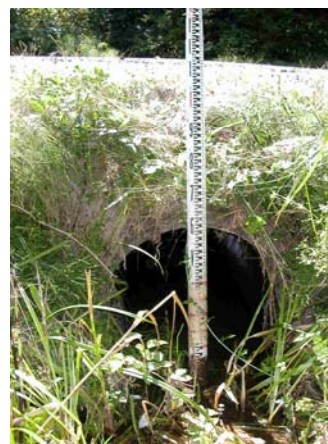
Plunge pool and stream width measurements not available due to wetland habitat downstream of site.

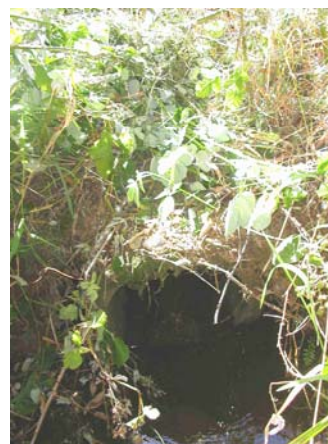
Last segment of pipe is separated and failing.

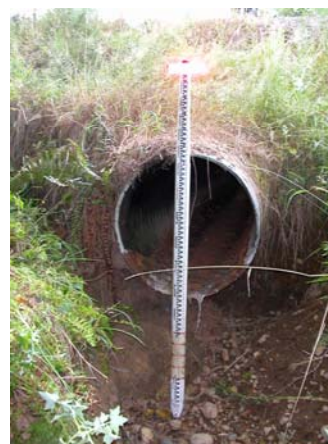
Review Date: 7/30/2003  
Field Crew: Glore/Peterson  
Barrier: Yes  
Passability (%): 33  
Method: LA  
Repair Status: UD  
Problem: outfall drop, slope

Sequencer: 1.1  
Shape: RND  
Material: CST  
Span (m): 0.63  
Rise (m): 0.62  
Length (m): 18.51  
Slope (%): 2.40  
Bed Material: No  
Outfall Drop (m): 0.25  
WDIC (m): 0.00  
Apron: No  
Fill Depth (m): 1.00  
Tidegate: No

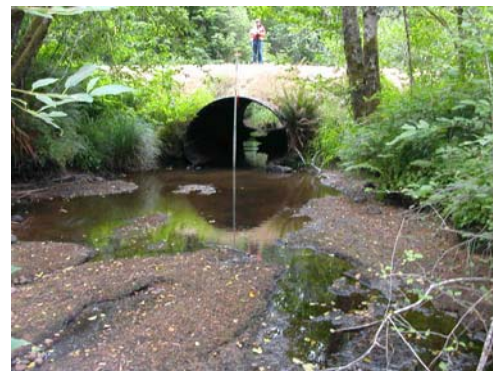
Review Date: 7/30/2003  
Field Crew: Glore/Peterson  
Barrier: Yes  
Passability (%): 67  
Method: LA  
Repair Status: UD  
Problem: slope

Sequencer: 1.1  
Shape: RND  
Material: CST  
Span (m): 2.91  
Rise (m): 2.06  
Length (m): 18.41  
Slope (%): 1.40  
Bed Material: No  
Outfall Drop (m): 0.00  
WDIC (m): 0.17  
Apron: No  
Fill Depth (m): 1.00  
Tidegate: No

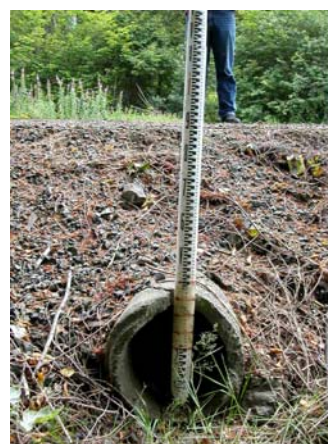
Downstream end is crushed and broken.  
Potential natural point barrier downstream.

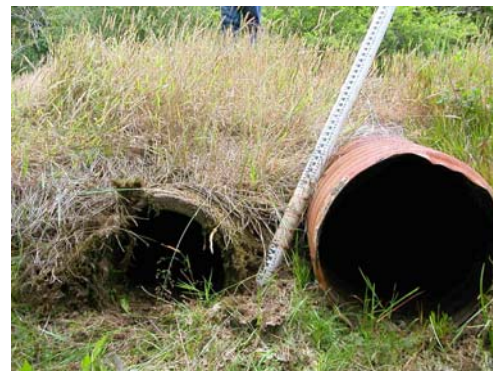
Pipe 1.2 is on left bank. Potential natural point barrier downstream.

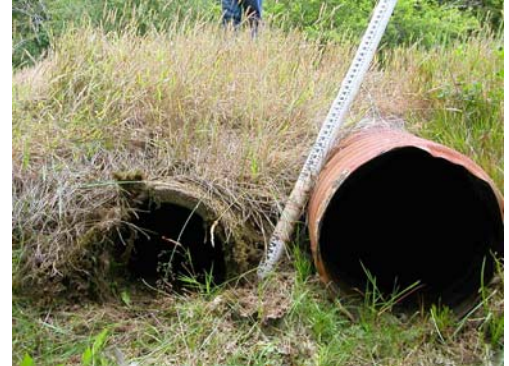
Pipe 2.2 is on right bank. Potential natural point barrier downstream.

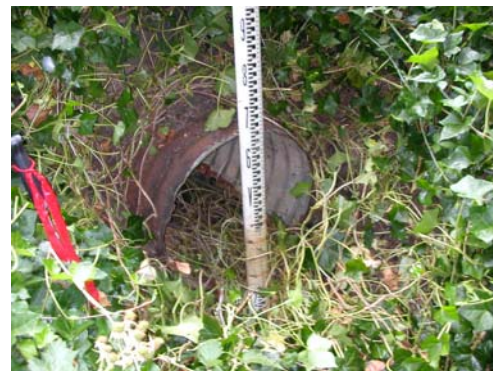
Bottom of pipe rusted out on downstream end.

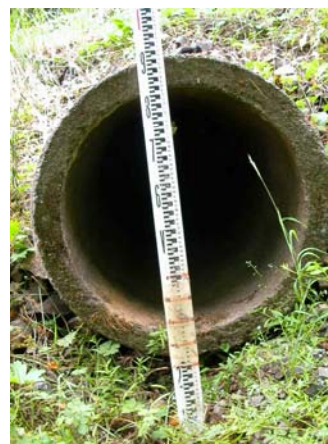
Natural point barrier 25 meters downstream of pipe.

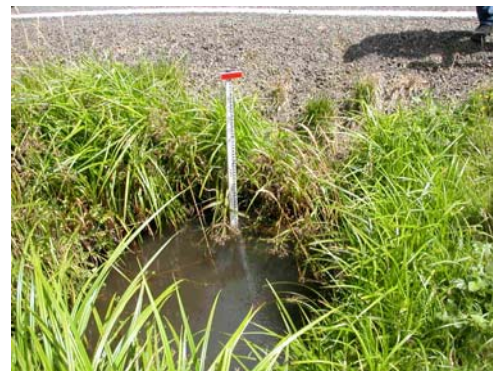
Landowner who lives near culvert reports that there is a natural point barrier downstream.

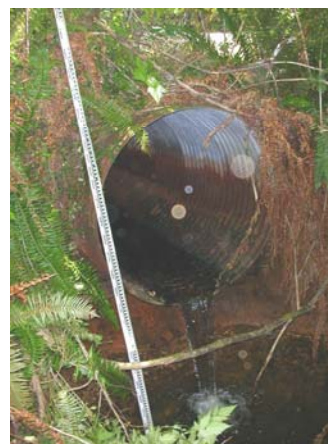
Review Date:	7/30/2003
Field Crew:	Glore/Peterson
Barrier	Yes
Passability (%)	33
Method	LA
Repair Status	UD
Problem	outfall drop, slope

Sequencer:	1.1
Shape	RND
Material	CST
Span (m)	1.26
Rise (m)	1.22
Length (m)	13.60
Slope (%)	1.60
Bed Material	No
Outfall Drop (m)	0.82
WDIC (m)	0.04
Apron	No
Fill Depth (m)	1.00
Tidegate	No

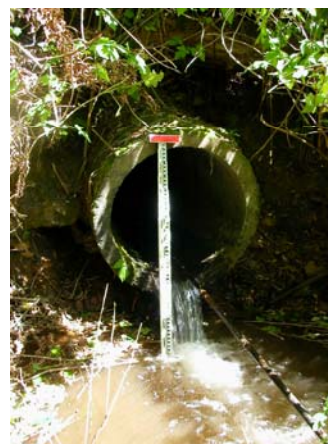
Review Date:	7/30/2003
Field Crew:	Glore/Peterson
Barrier	Yes
Passability (%)	67
Method	LA
Repair Status	UD
Problem	outfall drop

Sequencer:	1.1
Shape	RND
Material	PCC
Span (m)	0.79
Rise (m)	0.79
Length (m)	25.44
Slope (%)	0.58
Bed Material	No
Outfall Drop (m)	0.35
WDIC (m)	0.08
Apron	No
Fill Depth (m)	3.00
Tidegate	No

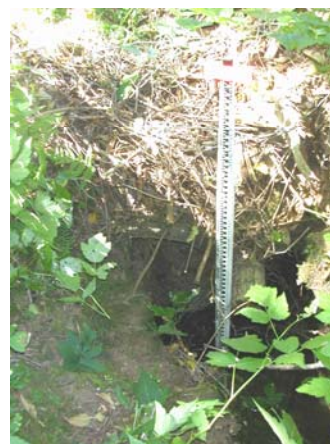
Pipe smashed on upstream end.

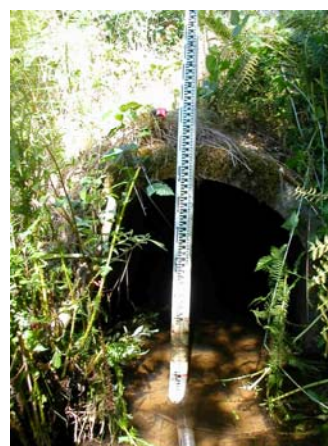
Level B not applicable due to lack of downstream control.

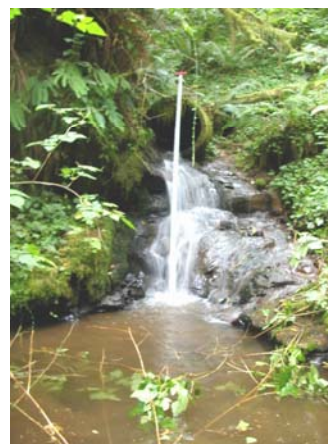
Review Date: 8/7/2003  
Field Crew: Glore/Peterson  
Barrier: Yes  
Passability (%): 0  
Method: LA  
Repair Status: UD  
Problem: outfall drop, slope

Sequencer: 1.1  
Shape: RND  
Material: PCC  
Span (m): 0.76  
Rise (m): 0.76  
Length (m): 57.76  
Slope (%): 5.80  
Bed Material: No  
Outfall Drop (m): 2.10  
WDIC (m): 0.03  
Apron: No  
Fill Depth (m): 13.00  
Tidegate: No

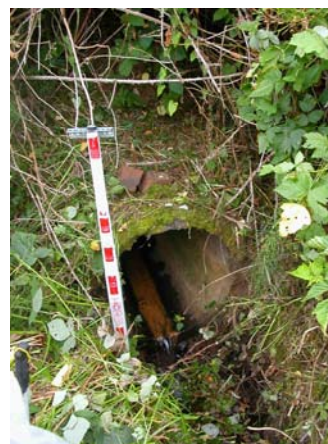
Review Date: 8/7/2003  
Field Crew: Glore/Peterson  
Barrier: Yes  
Passability (%): 33  
Method: LA  
Repair Status: UD  
Problem: outfall drop, slope

Channel is ditched on downstream end.

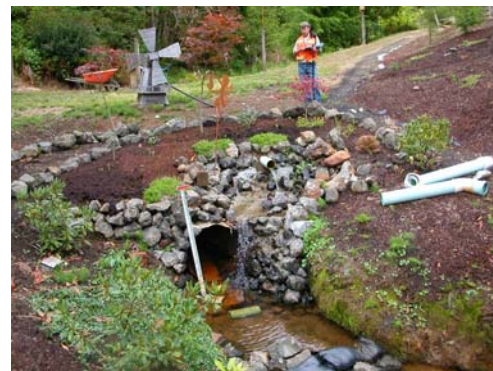
Artificial waterfall on downstream end. Vertical intake on upstream end is 0.5 meters tall.

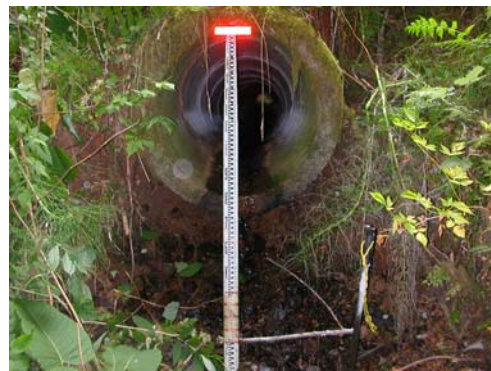
Review Date: 8/7/2003  
Field Crew: Glore/Peterson  
Barrier: Yes  
Passability (%): 33  
Method: LA  
Repair Status: UD  
Problem: outfall drop, slope

No plunge pool measurements due to confluence with adjacent stream. Outfall is onto 3.0 meter slide. Fish passage most likely zero.

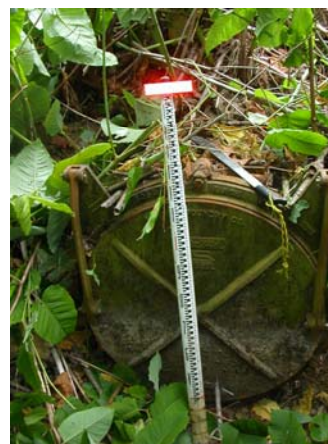
Review Date: 8/7/2003  
Field Crew: Glore/Peterson  
Barrier: Unk  
Passability (%):  
Method: LBNA  
Repair Status:  
Problem:

Level B not applicable due to tidal influences.

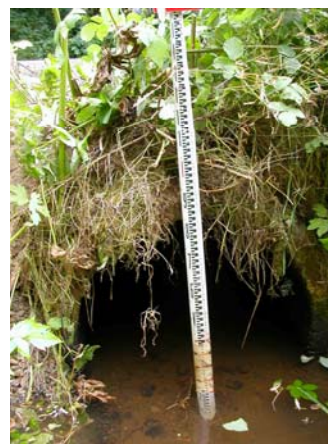
Review Date: 8/7/2003  
Field Crew: Glore/Peterson  
Barrier: Yes  
Passability (%): 67  
Method: LA  
Repair Status: UD  
Problem: slope

Sequencer: 1.1  
Shape: RND  
Material: PCC  
Span (m): 0.94  
Rise (m): 0.94  
Length (m): 12.99  
Slope (%): 1.80  
Bed Material: No  
Outfall Drop (m): 0.00  
WDIC (m): 0.18  
Apron: No  
Fill Depth (m): 1.00  
Tidegate: No

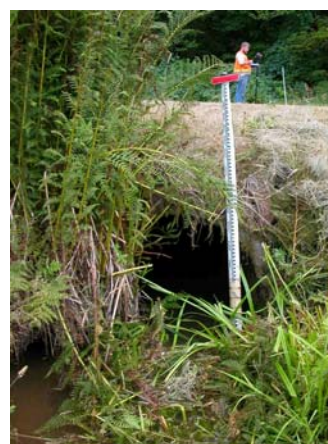
Review Date: 8/7/2003  
Field Crew: Glore/Peterson  
Barrier: Yes  
Passability (%): 67  
Method: LA  
Repair Status: UD  
Problem: slope

Stream channel has been modified, filled stream with gravel substrate during road widening project.

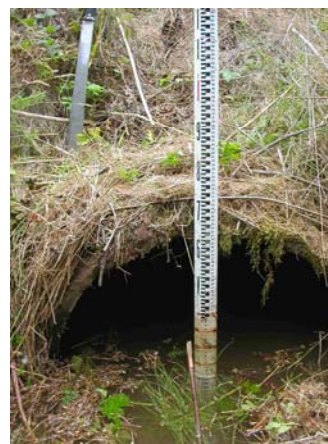
Review Date:	8/7/2003
Field Crew:	Glore/Peterson
Barrier	No
Passability (%)	100
Method	LA
Repair Status	OK
Problem

Sequencer:	1.1
Shape	RND
Material	CST
Span (m)	0.85
Rise (m)	0.85
Length (m)	7.42
Slope (%)	0.94
Bed Material	Yes
Outfall Drop (m)	0.00
WDIC (m)	0.17
Apron	No
Fill Depth (m)	1.00
Tidegate	No

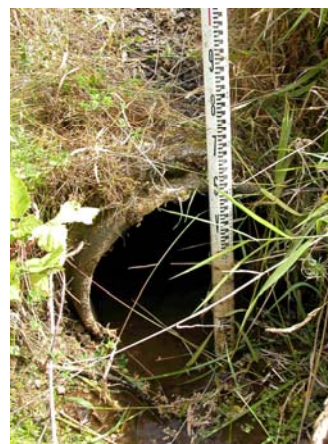
Review Date:	8/7/2003
Field Crew:	Glore/Peterson
Barrier	No
Passability (%)	100
Method	LA
Repair Status	OK
Problem

Sequencer:	1.1
Shape	RND
Material	PCC
Span (m)	0.94
Rise (m)	0.94
Length (m)	12.98
Slope (%)	0.00
Bed Material	Yes
Outfall Drop (m)	0.00
WDIC (m)	0.22
Apron	No
Fill Depth (m)	1.00
Tidegate	No

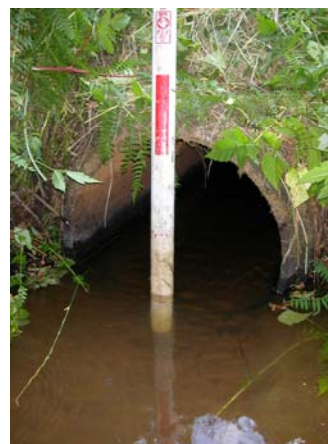
Review Date:	8/7/2003
Field Crew:	Glore/Peterson
Barrier	Unk
Passability (%)	
Method	LBNA
Repair Status	
Problem

Level B not applicable due to lack of downstream control.

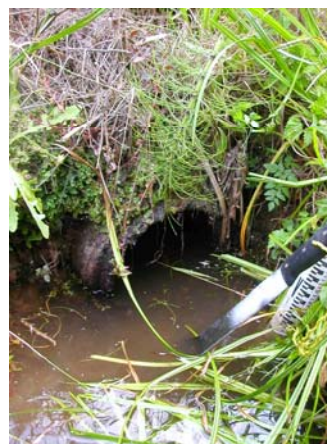
Review Date:	8/7/2003
Field Crew:	Glore/Peterson
Barrier	Unk
Passability (%)	
Method	LBNA
Repair Status	
Problem

Level B not applicable due to lack of downstream control.

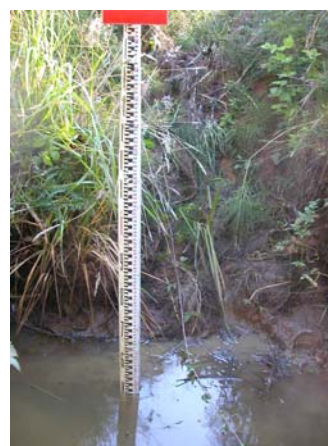
Downstream end is buried and upstream end has broken off. Measurements not obtainable due to wetland downstream and failed culvert.

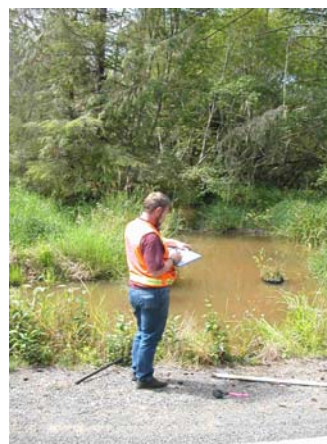
Review Date:	8/13/2003
Field Crew:	Glore/Peterson
Barrier	Unk
Passability (%)	
Method	
Repair Status	
Problem

Unable to obtain measurements because pipe is submerged out of sight on both ends. Wire mesh screen on upstream end of pipe, small beaver dam 10 meters downstream of pipe.

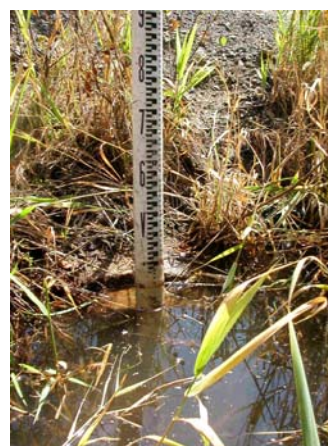
Review Date:	8/13/2003
Field Crew:	Glore/Peterson
Barrier	Unk
Passability (%)	
Method	LBNA
Repair Status	
Problem

Level B not applicable due to lack of downstream control.

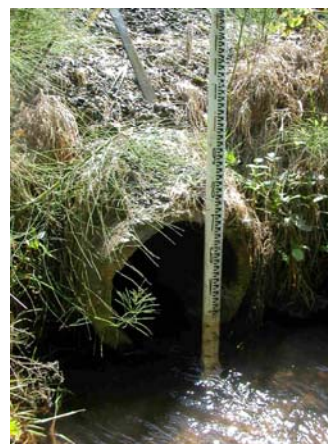
Review Date:	8/13/2003
Field Crew:	Glore/Peterson
Barrier	Yes
Passability (%)	67
Method	LA
Repair Status	UD
Problem	slope

Stream channel is excavated on upstream end.

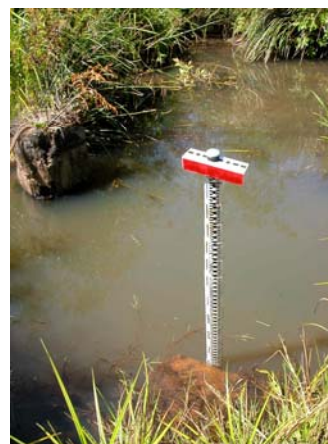
Review Date:	8/13/2003
Field Crew:	Glore/Peterson
Barrier	Yes
Passability (%)	67
Method	LA
Repair Status	UD
Problem	slope

Downstream channel is excavated through wetland. Backwatered ditch delivery upstream of pipe.

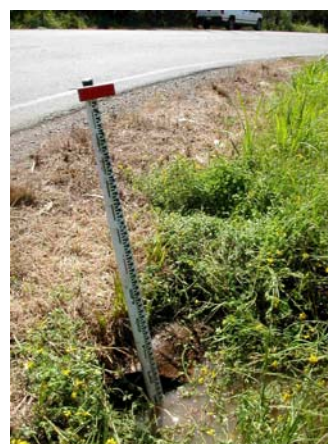
Level B not applicable due to lack of downstream control.

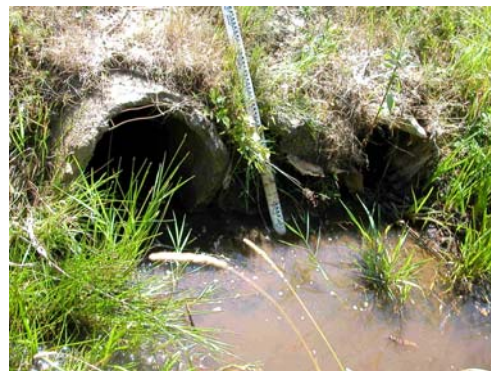
Review Date:	8/13/2003
Field Crew:	Glore/Peterson
Barrier	Yes
Passability (%)	67
Method	LA
Repair Status	UD
Problem	slope

Rebar grate on upstream end of pipe. Toe width unavailable due to channel modification.

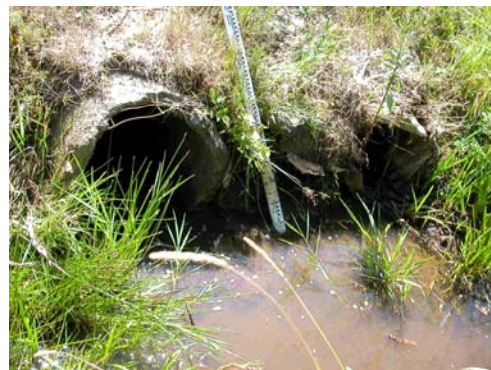
Rebar grate on upstream end of pipe, end broken off lying in pool above pipe.

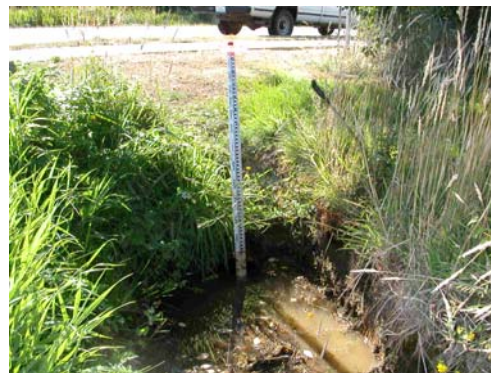
Upstream end of culvert is precast concrete with a smooth steel pipe on downstream end. Level B not applicable due to grade break within culvert.

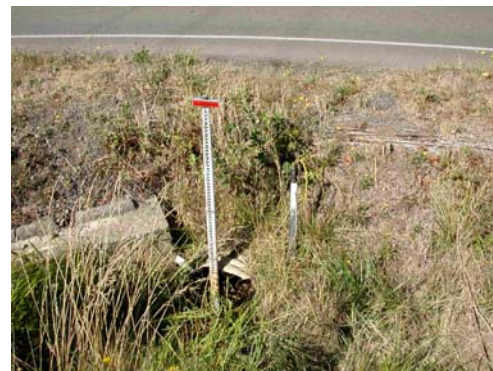
Culvert 1.2 fails due to 2.2 failure.

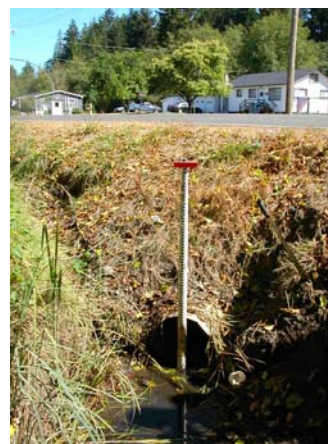
Review Date:	8/18/2003
Field Crew:	Glore/Lutz
Barrier	Yes
Passability (%)	67
Method	LA
Repair Status	UD
Problem	slope

Excavated ditch drainage upstream and downstream.

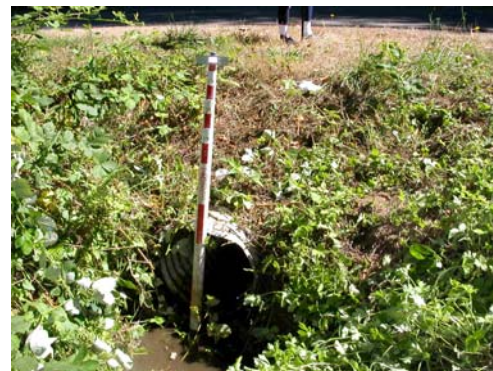
Review Date:	8/18/2003
Field Crew:	Glore/Lutz
Barrier	Yes
Passability (%)	67
Method	LA
Repair Status	UD
Problem	slope

Sequencer:	1.1
Shape	RND
Material	CAL
Span (m)	0.54
Rise (m)	0.52
Length (m)	18.38
Slope (%)	4.03
Bed Material	No
Outfall Drop (m)	0.05
WDIC (m)	0.03
Apron	No
Fill Depth (m)	1.00
Tidegate	No

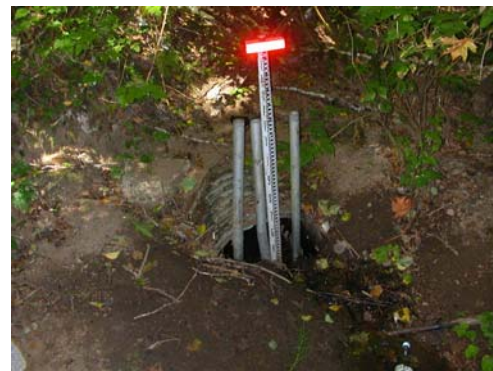
Review Date:	8/18/2003
Field Crew:	Glore/Lutz
Barrier	Unk
Passability (%)	
Method	LA
Repair Status	
Problem

Level A evaluation not possible, unable to locate downstream end.

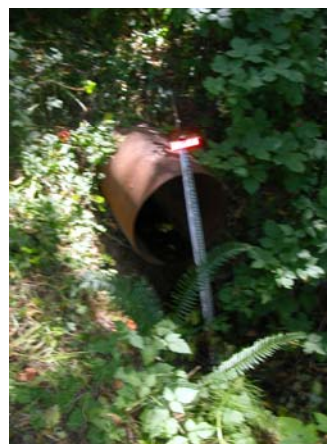
Review Date:	8/18/2003
Field Crew:	Glore/Lutz
Barrier	Yes
Passability (%)	67
Method	LA
Repair Status	UD
Problem	outfall drop

Stream width measurements not available due to ditching. Bars on upstream end of culvert act a grate. Second culvert 5 meters downstream, site 127Q0118.

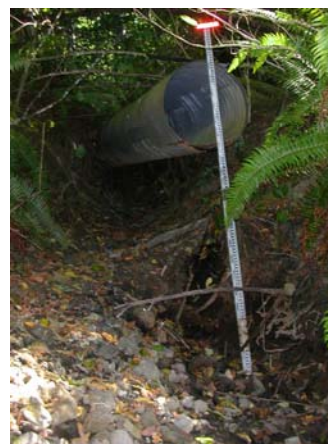
Rebar grating on upstream end of culvert. Stream width measurements not available due to ditching. Fish passage most likely near zero.

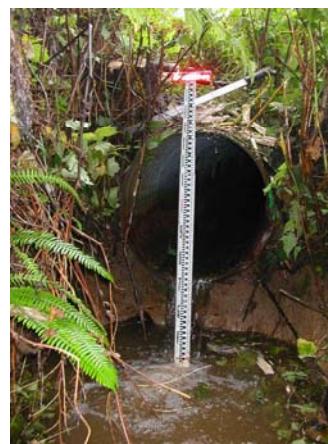
Review Date: 9/11/2003  
Field Crew: Glore/Lutz  
Barrier: Yes  
Passability (%): 33  
Method: LA  
Repair Status: UD  
Problem: outfall drop, slope

Sequencer: 1.1  
Shape: RND  
Material: CST  
Span (m): 0.84  
Rise (m): 0.82  
Length (m): 12.21  
Slope (%): 4.00  
Bed Material: No  
Outfall Drop (m): 0.35  
WDIC (m): 0.04  
Apron: No  
Fill Depth (m): 1.00  
Tidegate: No

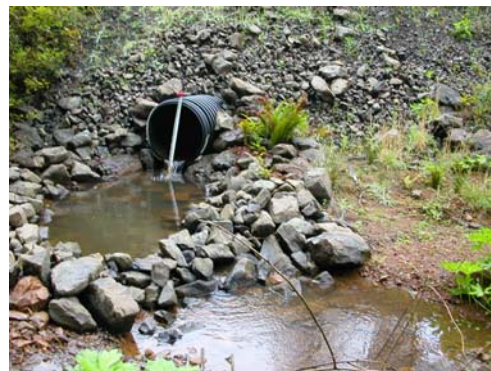
Review Date:	9/11/2003
Field Crew:	Glore/Lutz
Barrier	No
Passability (%)	100
Method	LB
Repair Status	OK
Problem

Highly modified plunge pool, water flowing through rip rap at downstream control.

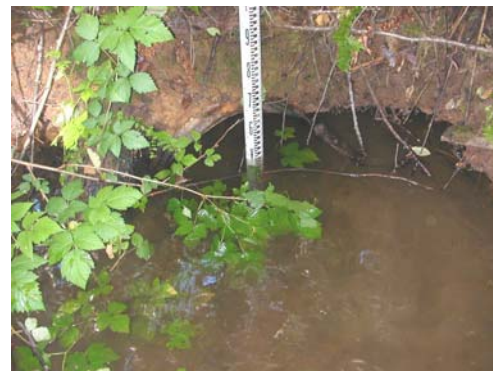
Review Date:	9/22/2003
Field Crew:	Glore/Lutz
Barrier	Yes
Passability (%)	67
Method	LA
Repair Status	RR
Problem	slope

Sequencer:	1.1
Shape	RND
Material	CST
Span (m)	0.62
Rise (m)	0.60
Length (m)	7.54
Slope (%)	4.90
Bed Material	No
Outfall Drop (m)	0.00
WDIC (m)	0.46
Apron	No
Fill Depth (m)	0.60
Tidegate	No

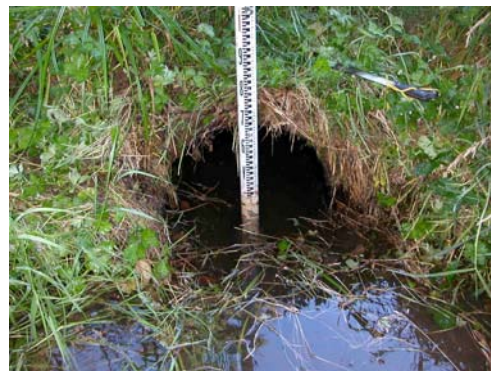
Review Date:	9/22/2003
Field Crew:	Glore/Lutz
Barrier	Yes
Passability (%)	67
Method	LA
Repair Status	RR
Problem	slope

Thin layer of fine materials throughout pipe.

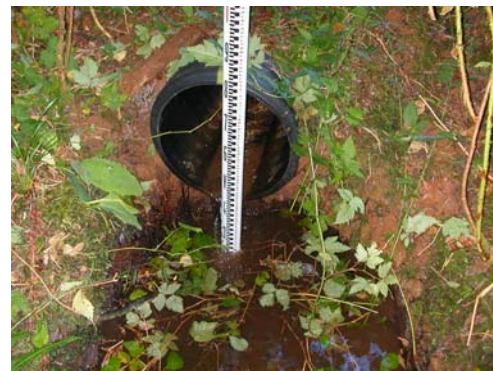
1.2 is left bank culvert.

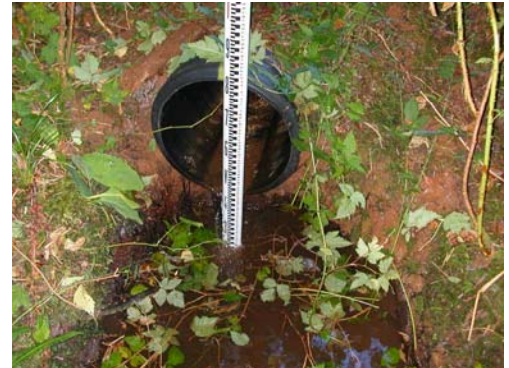
2.2 is right bank culvert

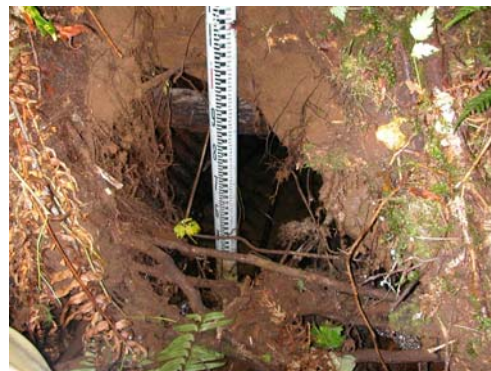
Review Date:	9/22/2003
Field Crew:	Glore/Lutz
Barrier	Yes
Passability (%)	67
Method	LA
Repair Status	RR
Problem	slope

Downstream end of pipe is recessed 0.5 meters. Upstream end is clogged with debris and pipe is squashed to oval shape. Plunge pool measurements unavailable as stream flows directly into riffles below the pipe.

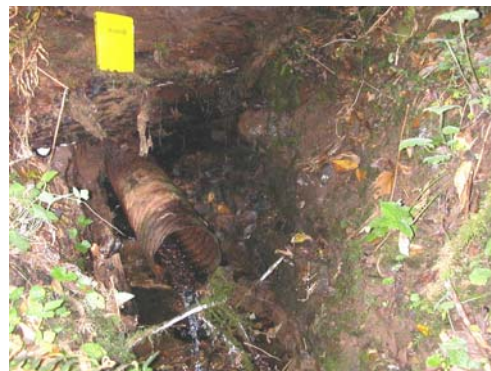
Review Date:	9/24/2003
Field Crew:	Glore/Lutz
Barrier	Yes
Passability (%)	33
Method	LA
Repair Status	RR
Problem	outfall drop, slope

Upstream end of pipe sits above stream, water flows through and beneath the downstream end of the pipe. Fish passage most likely near zero.

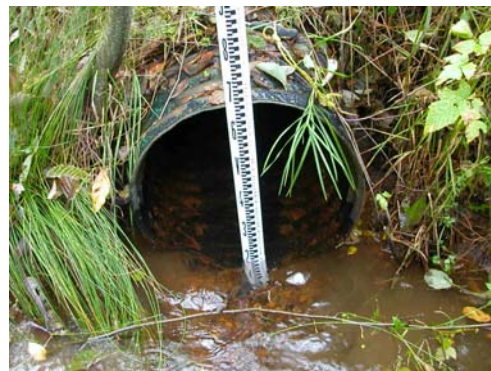
Culvert fails for slope, margin of error makes 0.97=1%.

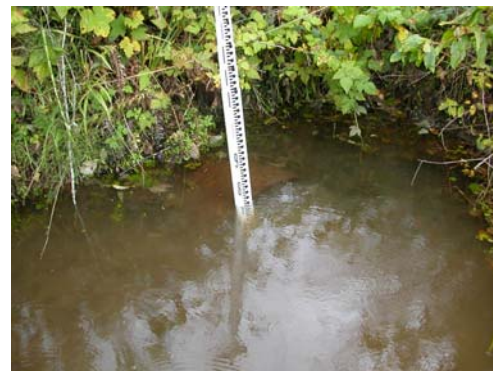
Plunge pool obscured by downstream wetland (upstream toe = 1.02). Both ends of pipe submerged, upstream end deformed. Level B not applicable due to lack of downstream control.

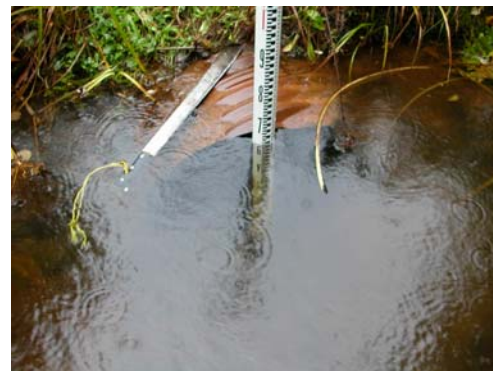
Review Date: 10/29/2003  
Field Crew: Gloire/Lutz  
Barrier: Unk  
Passability (%):  
Method: LBNA  
Repair Status:  
Problem:

Toe measurement taken US of culvert. Level B not applicable due to wetland habitat.

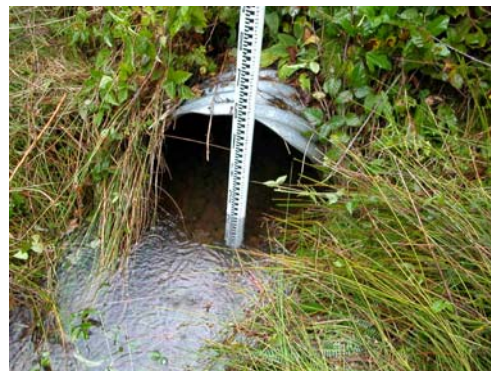
Review Date:	10/29/2003
Field Crew:	Glore/Lutz
Barrier	Yes
Passability (%)	67
Method	LB
Repair Status	UD
Problem	velocity

Small beaver dam approximately 50 meters downstream, stream flow decreases beyond.

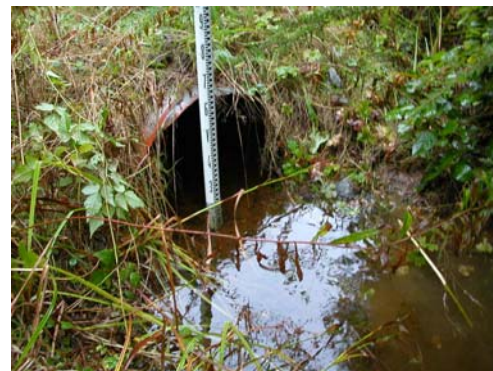
Review Date:	10/29/2003
Field Crew:	Glore/Lutz
Barrier	Yes
Passability (%)	67
Method	LA
Repair Status	UD
Problem	slope

Sequencer:	1.1
Shape	RND
Material	CST
Span (m)	0.61
Rise (m)	0.61
Length (m)	9.02
Slope (%)	2.70
Bed Material	No
Outfall Drop (m)	0.00
WDIC (m)	0.22
Apron	No
Fill Depth (m)	1.00
Tidegate	No

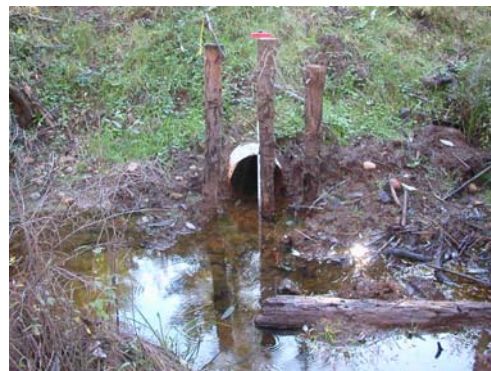
Review Date: 10/30/2003  
Field Crew: Glore/Lutz  
Barrier: Yes  
Passability (%): 67  
Method: LA  
Repair Status: UD  
Problem: slope

Three pilings located at upstream end of culvert discourage debris jams in pipe.

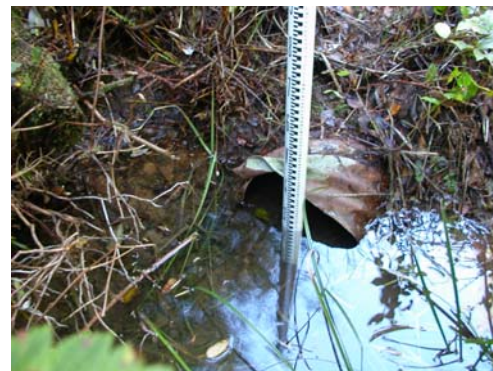
Sequencer:	1.1
Shape	RND
Material	CST
Span (m)	0.45
Rise (m)	0.46
Length (m)	
Slope (%)	
Bed Material	No
Outfall Drop (m)	0.00
WDIC (m)	0.03
Apron	No
Fill Depth (m)	1.50
Tidegate	No

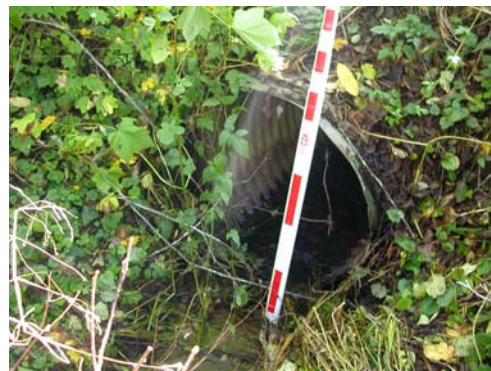
Review Date:	10/30/2003
Field Crew:	Glore/Lutz
Barrier	Yes
Passability (%)	67
Method	LA
Repair Status	UD
Problem	slope

Sequencer:	1.1
Shape	RND
Material	CAL
Span (m)	0.91
Rise (m)	0.91
Length (m)	14.54
Slope (%)	4.19
Bed Material	No
Outfall Drop (m)	0.00
WDIC (m)	0.26
Apron	No
Fill Depth (m)	2.00
Tidegate	No

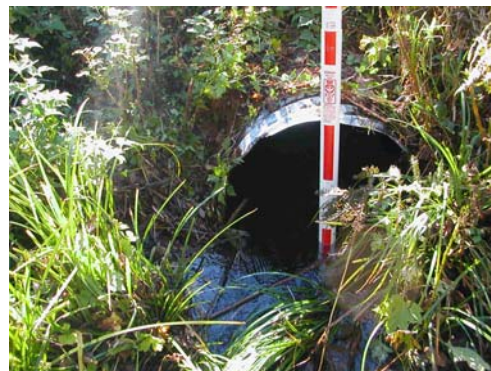
Review Date:	10/30/2003
Field Crew:	Glore/Lutz
Barrier	Unk
Passability (%)	
Method	LBNA
Repair Status	
Problem

Level B not applicable due to lack of downstream control.
