# **Hoquiam Drainage - Barrier Inventory Results**

# WRIA 22 Fish Passage Inventory

Mason Conservation District

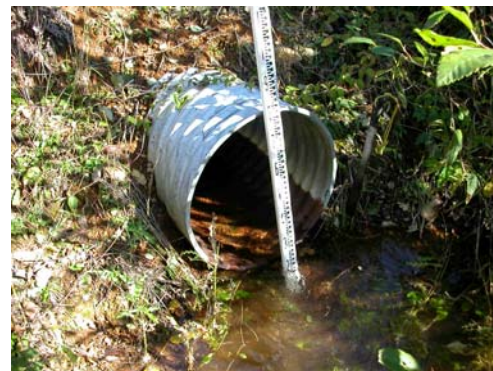
Review Date: 10/30/2003  
Field Crew: Glore/Lutz  
Barrier: Yes  
Passability (%): 67  
Method: LA  
Repair Status: UD  
Problem: slope

Sequencer: 1.1  
Shape: RND  
Material: CST  
Span (m): 0.61  
Rise (m): 0.61  
Length (m): 9.28  
Slope (%): 1.29  
Bed Material: No  
Outfall Drop (m): 0.02  
WDIC (m): 0.04  
Apron: No  
Fill Depth (m): 1.00  
Tidegate: No

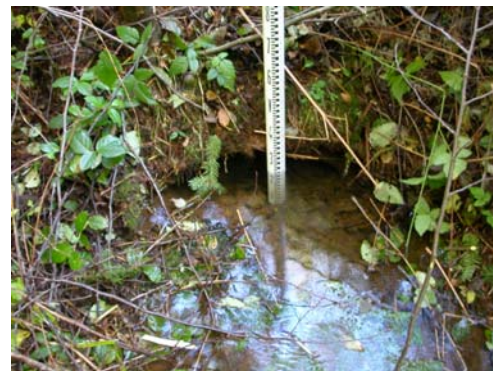
Review Date: 10/30/2003  
Field Crew: Glore/Lutz  
Barrier: No  
Passability (%): 100  
Method: LA  
Repair Status: OK  
Problem:

Sequencer: 1.1  
Shape: RND  
Material: CST  
Span (m): 0.76  
Rise (m): 0.75  
Length (m): 10.71  
Slope (%): 3.64  
Bed Material: Yes  
Outfall Drop (m): 0.00  
WDIC (m): 0.25  
Apron: No  
Fill Depth (m): 2.00  
Tidegate: No

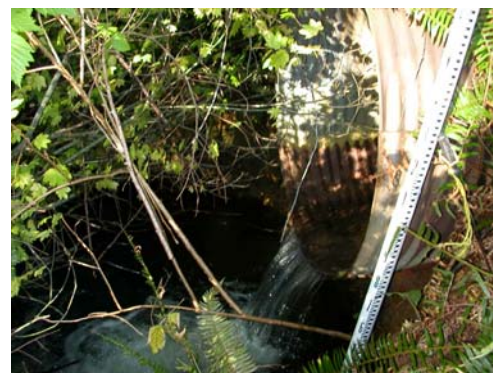
Review Date:	10/30/2003
Field Crew:	Glore/Lutz
Barrier	Yes
Passability (%)	33
Method	LA
Repair Status	UD
Problem	outfall drop, slope

Sequencer:	1.1
Shape	RND
Material	CST
Span (m)	1.49
Rise (m)	1.53
Length (m)	18.33
Slope (%)	2.24
Bed Material	No
Outfall Drop (m)	0.55
WDIC (m)	0.13
Apron	No
Fill Depth (m)	2.50
Tidegate	No

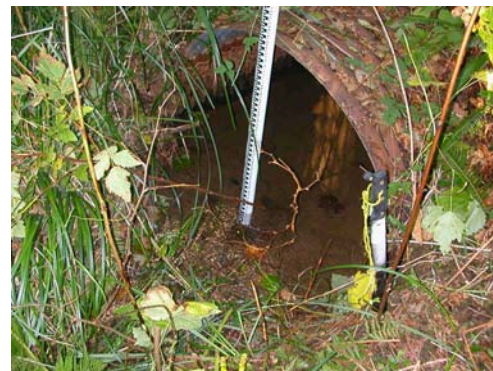
Review Date: 10/30/2003  
Field Crew: Glore/Lutz  
Barrier: No  
Passability (%): 100  
Method: LA  
Repair Status: OK  
Problem:

Sequencer: 1.1  
Shape: RND  
Material: CST  
Span (m): 1.19  
Rise (m): 1.24  
Length (m): 12.15  
Slope (%): 1.00  
Bed Material: Yes  
Outfall Drop (m): 0.00  
WDIC (m): 0.12  
Apron: No  
Fill Depth (m): 1.00  
Tidegate: No

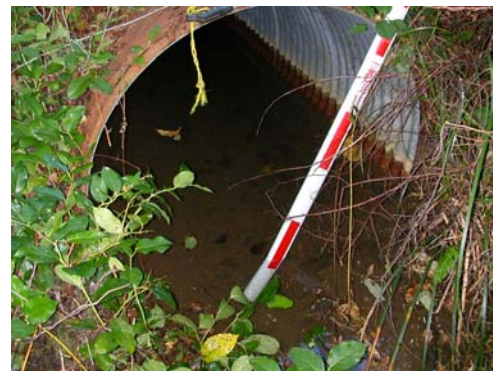
Review Date:	10/30/2003
Field Crew:	Glore/Lutz
Barrier	Yes
Passability (%)	67
Method	LA
Repair Status	UD
Problem	slope

Plunge pool measurements unavailable due to wetland influence downstream.

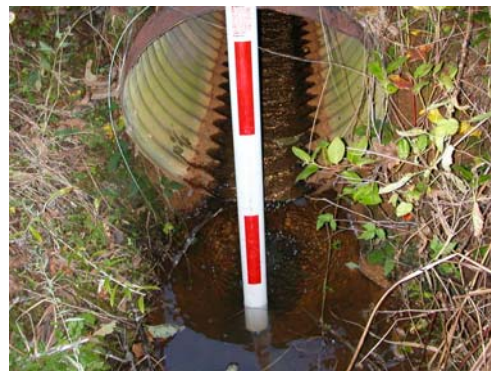
Review Date: 10/30/2003  
Field Crew: Glore/Lutz  
Barrier: Yes  
Passability (%): 33  
Method: LA  
Repair Status: UD  
Problem: slope

Sequencer: 1.1  
Shape: RND  
Material: CST  
Span (m): 0.63  
Rise (m): 0.63  
Length (m): 9.53  
Slope (%): 4.90  
Bed Material: No  
Outfall Drop (m): 0.18  
WDIC (m): 0.02  
Apron: No  
Fill Depth (m): 1.00  
Tidegate: No

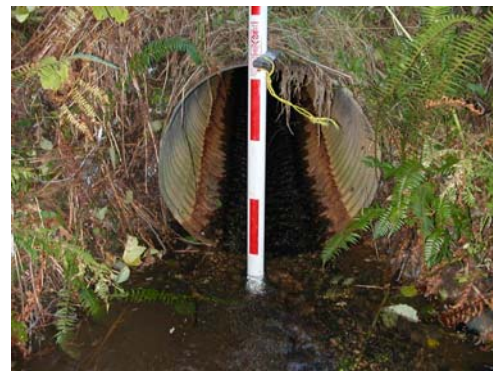
Review Date:	10/30/2003
Field Crew:	Glore/Lutz
Barrier	Yes
Passability (%)	67
Method	LA
Repair Status	UD
Problem	slope

Sequencer:	1.1
Shape	RND
Material	CST
Span (m)	0.76
Rise (m)	0.75
Length (m)	9.51
Slope (%)	2.50
Bed Material	No
Outfall Drop (m)	0.00
WDIC (m)	0.05
Apron	No
Fill Depth (m)	1.00
Tidegate	No

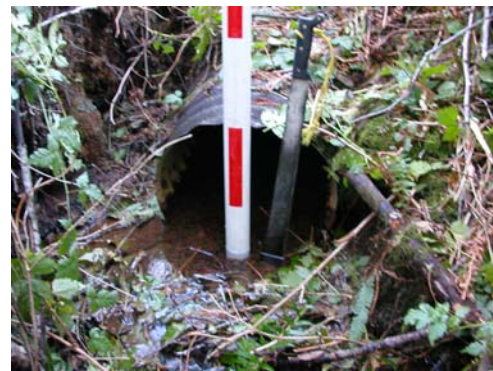
Review Date: 10/30/2003  
Field Crew: Glore/Lutz  
Barrier: Yes  
Passability (%): 67  
Method: LA  
Repair Status: UD  
Problem: slope

Sequencer: 1.1  
Shape: RND  
Material: CST  
Span (m): 0.47  
Rise (m): 0.46  
Length (m): 12.59  
Slope (%): 1.90  
Bed Material: No  
Outfall Drop (m): 0.00  
WDIC (m): 0.04  
Apron: No  
Fill Depth (m): 0.50  
Tidegate: No

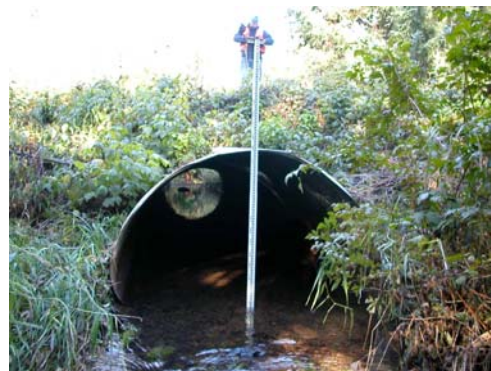
Review Date: 11/3/2003  
Field Crew: Glore/Lutz  
Barrier: No  
Passability (%): 100  
Method: LA  
Repair Status: OK  
Problem:

No plunge pool as stream flows into riffles immediately downstream of pipe.

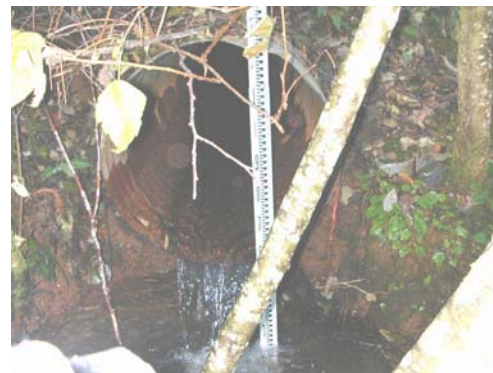
Review Date: 11/3/2003  
Field Crew: Glore/Lutz  
Barrier: Yes  
Passability (%): 67  
Method: LA  
Repair Status: UD  
Problem: outfall drop

Wetland habitat upstream and downstream makes toe measurement unobtainable. Length and slope shots not possible, unable to locate upstream end of culvert.

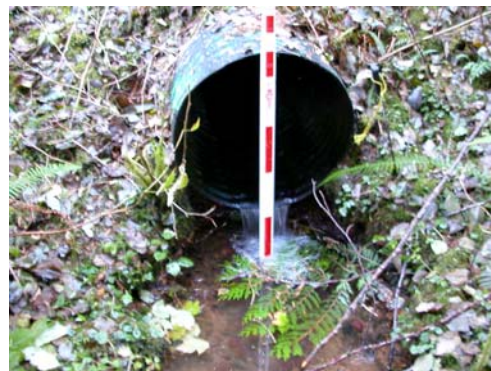
Review Date:	11/4/2003
Field Crew:	Glore/Lutz
Barrier	Yes
Passability (%)	67
Method	LA
Repair Status	UD
Problem	slope

3.5 meter high waterfall 15 meters downstream of culvert.

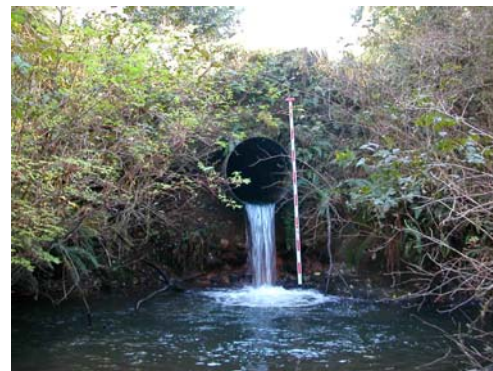
Review Date:	11/4/2003
Field Crew:	Glore/Lutz
Barrier	Yes
Passability (%)	33
Method	LA
Repair Status	UD
Problem	outfall drop

Sequencer:	1.1
Shape	RND
Material	CST
Span (m)	1.24
Rise (m)	1.25
Length (m)	28.49
Slope (%)	0.39
Bed Material	No
Outfall Drop (m)	1.60
WDIC (m)	0.12
Apron	No
Fill Depth (m)	5.00
Tidegate	No

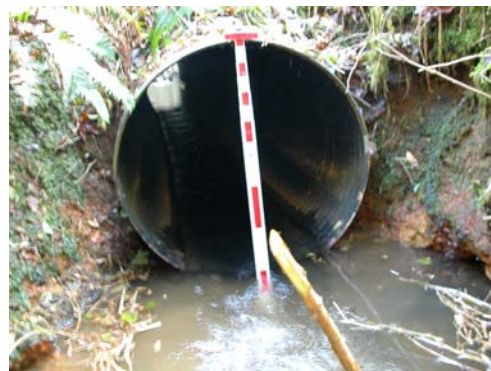
Review Date: 11/4/2003  
Field Crew: Glore/Lutz  
Barrier: Yes  
Passability (%): 67  
Method: LB  
Repair Status: UD  
Problem: velocity

Hip chain in stream downstream of pipe.

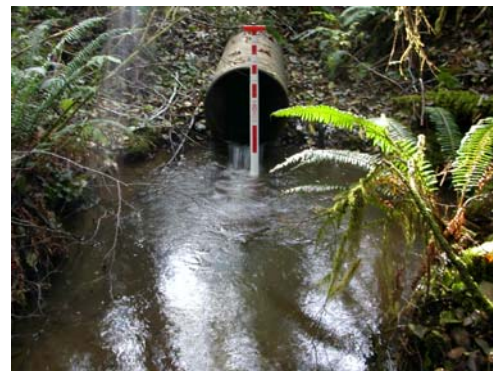
Review Date: 11/4/2003  
Field Crew: Glore/Lutz  
Barrier: Yes  
Passability (%): 67  
Method: LA  
Repair Status: UD  
Problem: slope

Sequencer: 1.1  
Shape: RND  
Material: CST  
Span (m): 0.61  
Rise (m): 0.61  
Length (m): 14.10  
Slope (%): 1.42  
Bed Material: No  
Outfall Drop (m): 0.19  
WDIC (m): 0.07  
Apron: No  
Fill Depth (m): 2.00  
Tidegate: No

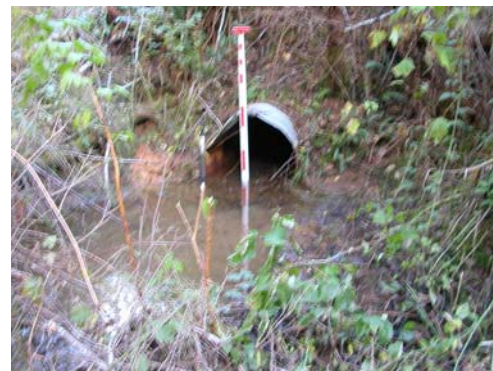
Review Date: 11/4/2003  
Field Crew: Glore/Lutz  
Barrier: Yes  
Passability (%): 67  
Method: LA  
Repair Status: UD  
Problem: slope

Unable to obtain toe or OHW width due to subsurface flows and wetland influence.

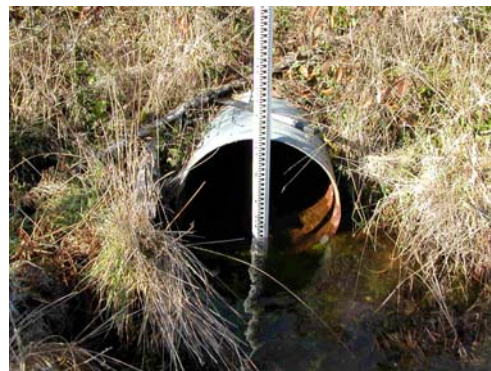
Review Date:	11/5/2003
Field Crew:	Glore/Lutz
Barrier	Yes
Passability (%)	67
Method	LA
Repair Status	UD
Problem	slope

Toe measurement unavailable as flow fans out through marshy area.

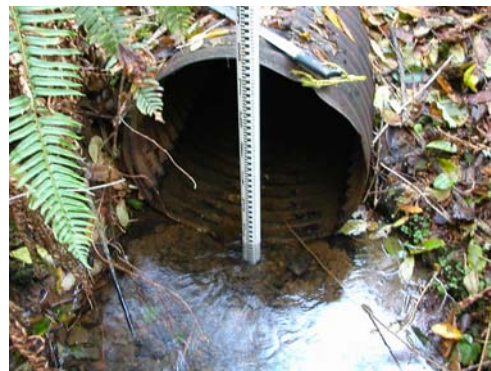
Review Date:	11/5/2003
Field Crew:	Glore/Lutz
Barrier	Yes
Passability (%)	67
Method	LA
Repair Status	UD
Problem	slope

Sequencer:	1.1
Shape	RND
Material	CST
Span (m)	0.76
Rise (m)	0.76
Length (m)	17.87
Slope (%)	1.00
Bed Material	No
Outfall Drop (m)	0.00
WDIC (m)	0.16
Apron	No
Fill Depth (m)	2.50
Tidegate	No

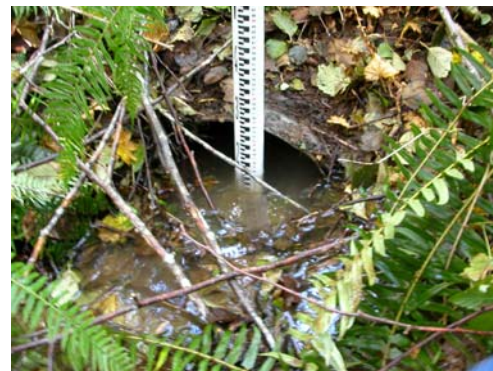
Review Date:	11/5/2003
Field Crew:	Glore/Lutz
Barrier	No
Passability (%)	100
Method	LA
Repair Status	OK
Problem

No plunge pool riffle at downstream end.

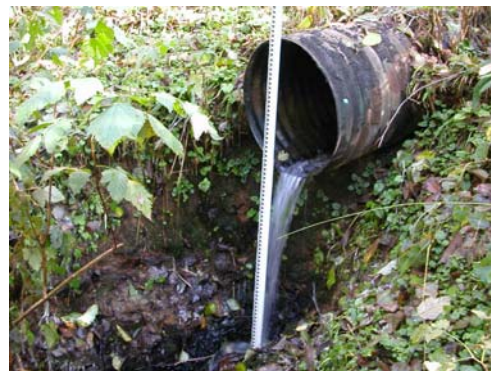
Review Date:	11/5/2003
Field Crew:	Glore/Lutz
Barrier	Yes
Passability (%)	33
Method	LA
Repair Status	UD
Problem	outfall drop, slope

Sequencer:	1.1
Shape	RND
Material	CST
Span (m)	0.60
Rise (m)	0.60
Length (m)	17.10
Slope (%)	11.50
Bed Material	No
Outfall Drop (m)	0.94
WDIC (m)	0.02
Apron	No
Fill Depth (m)	2.00
Tidegate	No

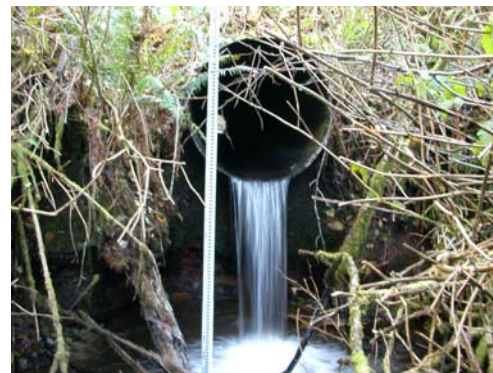
Review Date: 11/5/2003  
Field Crew: Glore/Lutz  
Barrier: Yes  
Passability (%): 33  
Method: LA  
Repair Status: UD  
Problem: outfall drop, slope

Sequencer: 1.1  
Shape: RND  
Material: CST  
Span (m): 1.05  
Rise (m): 1.05  
Length (m): 18.90  
Slope (%): 2.75  
Bed Material: No  
Outfall Drop (m): 1.15  
WDIC (m): 0.08  
Apron: No  
Fill Depth (m): 3.00  
Tidegate: No

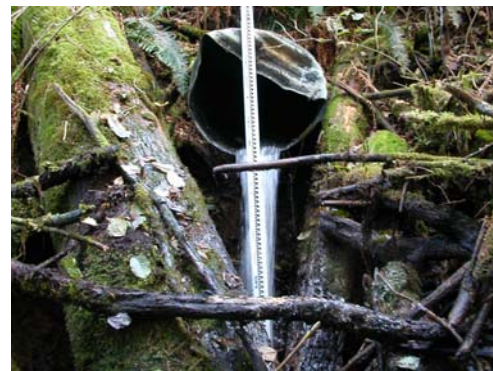
Review Date: 11/5/2003  
Field Crew: Glore/Lutz  
Barrier: Yes  
Passability (%): 33  
Method: LA  
Repair Status: UD  
Problem: outfall drop; slope

Plunge pool and stream width measurements unavailable due to wetland influence. Hinged addition on downstream end of pipe, outfall is onto debris pile.

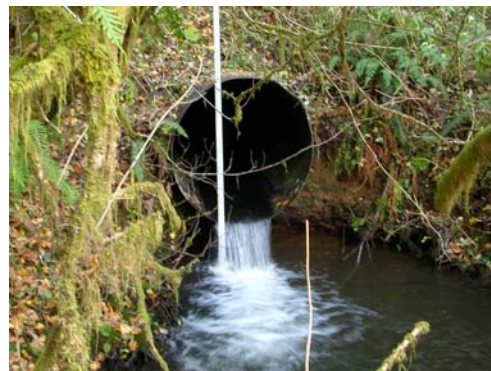
Review Date:	11/5/2003
Field Crew:	Glore/Lutz
Barrier	Yes
Passability (%)	33
Method	LA
Repair Status	UD
Problem	outfall drop, slope

Sequencer:	1.1
Shape	RND
Material	CST
Span (m)	1.45
Rise (m)	1.54
Length (m)	26.71
Slope (%)	2.80
Bed Material	No
Outfall Drop (m)	0.45
WDIC (m)	0.09
Apron	No
Fill Depth (m)	4.00
Tidegate	No

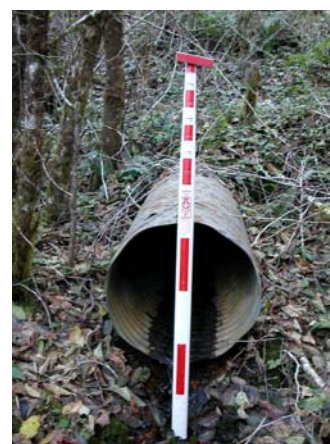
Sequencer: 1.1  
Shape: RND  
Material: CST  
Span (m): 0.62  
Rise (m): 0.62  
Length (m):  
Slope (%):  
Bed Material: No  
Outfall Drop (m): 0.22  
WDIC (m): 0.01  
Apron: No  
Fill Depth (m): 4.50  
Tidegate: No

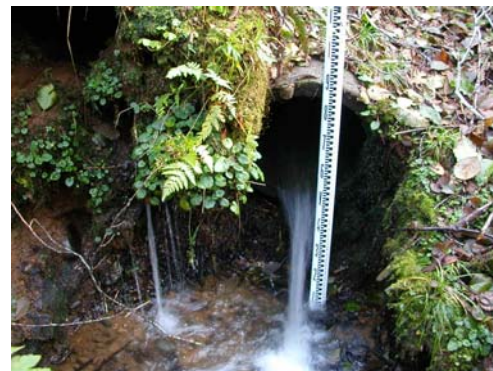
Review Date: 11/5/2003  
Field Crew: Glore/Lutz  
Barrier: Yes  
Passability (%): 33  
Method: LA  
Repair Status: UD  
Problem: outfall drop, slope

Last meter of pipe is dislodged creating grade break in pipe. Upstream end of pipe is round corrugated steel.

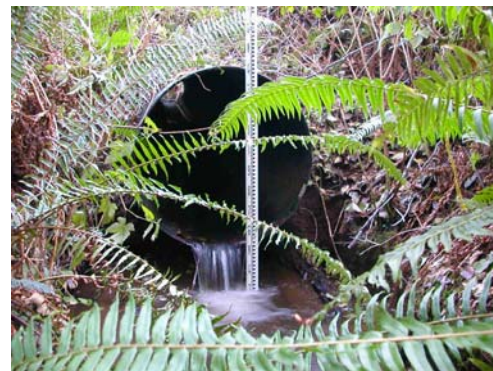
Review Date:	11/5/2003
Field Crew:	Glore/Lutz
Barrier	Yes
Passability (%)	33
Method	LA
Repair Status	UD
Problem	outfall drop, slope

Sequencer:	1.1
Shape	RND
Material	CST
Span (m)	0.88
Rise (m)	0.91
Length (m)	13.62
Slope (%)	4.30
Bed Material	No
Outfall Drop (m)	0.24
WDIC (m)	0.04
Apron	No
Fill Depth (m)	2.00
Tidegate	No

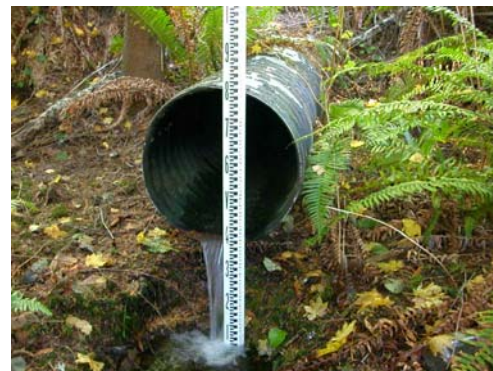
Sequencer: 1.1  
Shape: RND  
Material: CST  
Span (m): 0.44  
Rise (m): 0.45  
Length (m):  
Slope (%):  
Bed Material: No  
Outfall Drop (m): 0.30  
WDIC (m): 0.02  
Apron: No  
Fill Depth (m): 1.40  
Tidegate: No

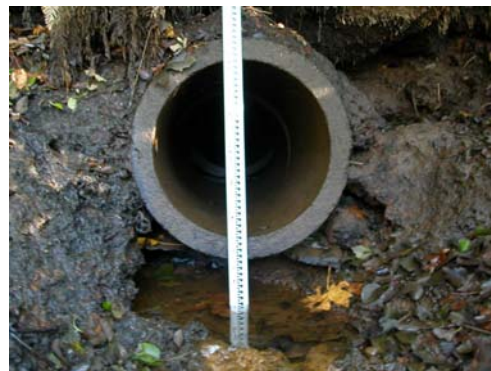
Last 2 sections of pipe are failing, creating a grade break in the pipe. No plunge pool or toe measurements as pipe empties directly into a wetland.

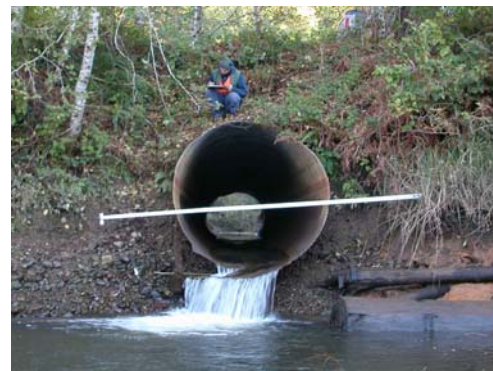
Review Date:	11/5/2003
Field Crew:	Glore/Lutz
Barrier	Yes
Passability (%)	67
Method	LA
Repair Status	UD
Problem	outfall drop

Sequencer:	1.1
Shape	RND
Material	CST
Span (m)	2.04
Rise (m)	2.13
Length (m)	26.63
Slope (%)	0.64
Bed Material	No
Outfall Drop (m)	0.60
WDIC (m)	0.19
Apron	No
Fill Depth (m)	2.40
Tidegate	No

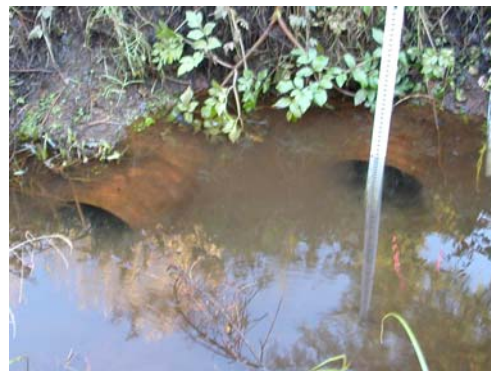
Both pipes submerged. Level B not applicable due to lack of downstream control.

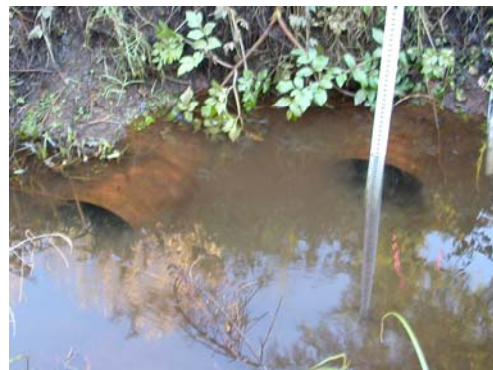
Culvert 2.2 is located on left bank. Level B not applicable due to lack of downstream control.

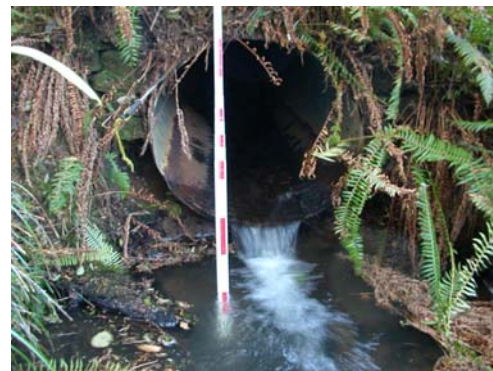
Review Date:	11/6/2003
Field Crew:	Glore/Lutz
Barrier	Yes
Passability (%)	67
Method	LA
Repair Status	UD
Problem	slope

Sequencer:	1.1
Shape	RND
Material	CST
Span (m)	1.24
Rise (m)	1.18
Length (m)	10.71
Slope (%)	3.92
Bed Material	No
Outfall Drop (m)	0.20
WDIC (m)	0.04
Apron	No
Fill Depth (m)	1.50
Tidegate	No

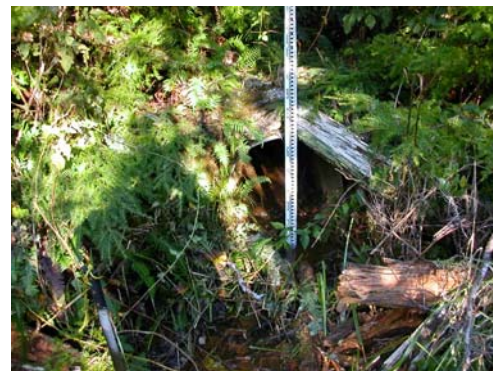
Review Date:	11/6/2003
Field Crew:	Glore/Lutz
Barrier	Yes
Passability (%)	33
Method	LA
Repair Status	UD
Problem	slope

Sequencer:	1.1
Shape	RND
Material	CST
Span (m)	0.62
Rise (m)	0.62
Length (m)	15.90
Slope (%)	9.10
Bed Material	No
Outfall Drop (m)	0.00
WDIC (m)	0.05
Apron	No
Fill Depth (m)	3.00
Tidegate	No

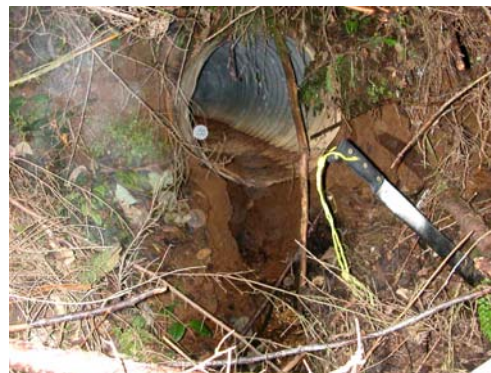
Water flows out from beneath the downstream end of the culvert.

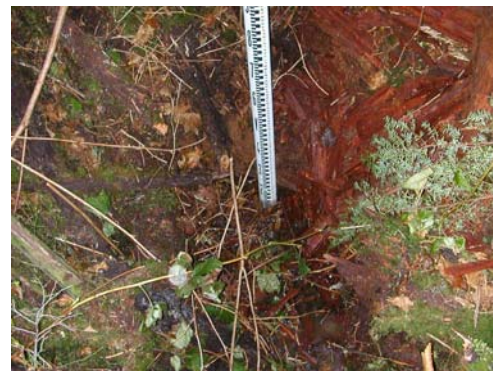
Review Date:	11/6/2003
Field Crew:	Glore/Lutz
Barrier	Yes
Passability (%)	33
Method	LA
Repair Status	UD
Problem	slope

Downstream end of culvert obscured by debris pile.

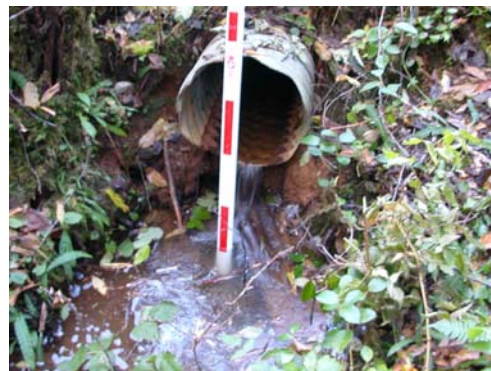
Review Date: 11/6/2003  
Field Crew: Glore/Lutz  
Barrier: Yes  
Passability (%): 33  
Method: LA  
Repair Status: UD  
Problem: outfall drop, slope

Sequencer: 1.1  
Shape: RND  
Material: CST  
Span (m): 0.48  
Rise (m): 0.48  
Length (m): 12.56  
Slope (%): 7.10  
Bed Material: No  
Outfall Drop (m): 0.30  
WDIC (m): 0.03  
Apron: No  
Fill Depth (m): 2.00  
Tidegate: No

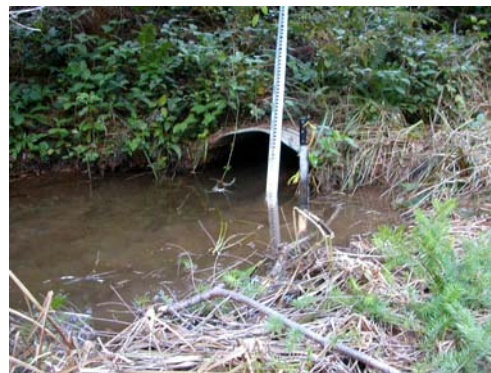
Upstream end of culvert is completely buried and unable to locate. No plunge pool or stream width measurements due to wetland immediately downstream of pipe.

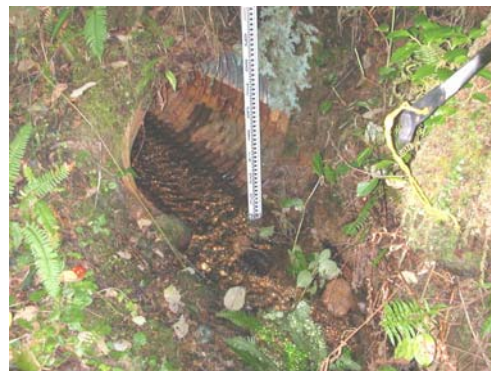
Review Date: 11/6/2003  
Field Crew: Glore/Lutz  
Barrier: Yes  
Passability (%): 67  
Method: LA  
Repair Status: UD  
Problem: slope

Riffles immediately downstream of the pipe make plunge pool measurements unobtainable.

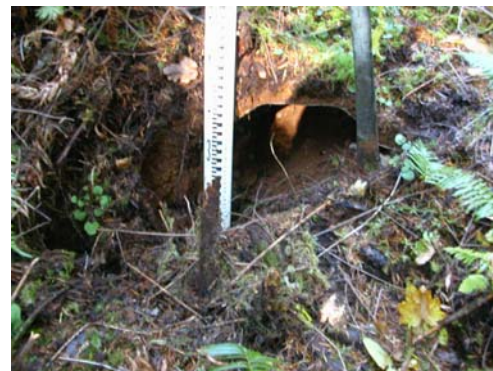
Downstream end of culvert is buried.

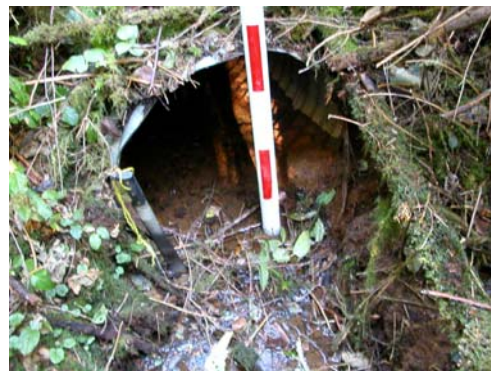
Review Date: 11/6/2003  
Field Crew: Glore/Lutz  
Barrier: Yes  
Passability (%): 67  
Method: LA  
Repair Status: UD  
Problem: slope

Riffles immediately downstream of culvert, no plunge pool.

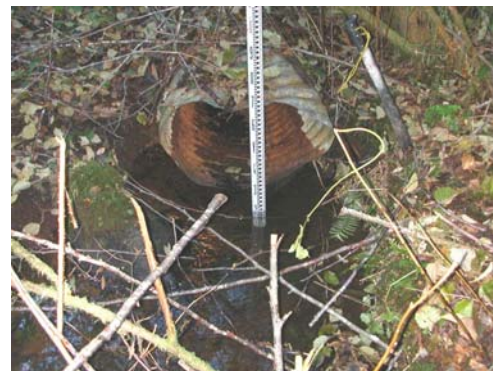
Culvert is rusted out on downstream end, no water is flowing through the pipe.

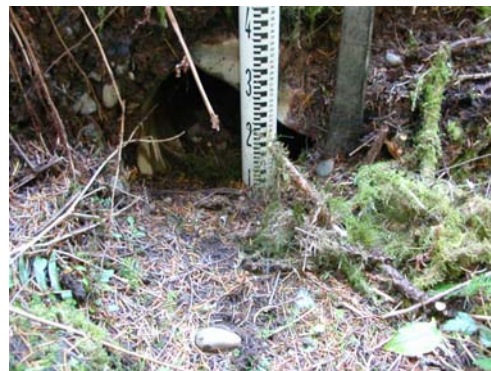
Downstream end of pipe is buried.

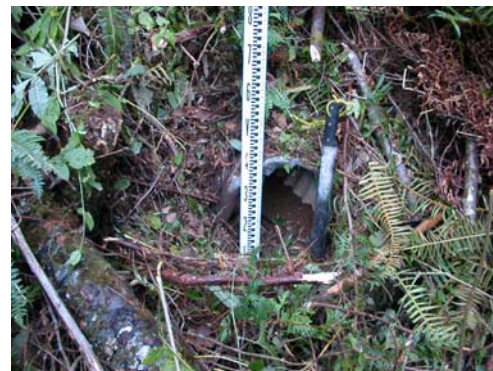
Downstream of pipe is choked with slash and debris.

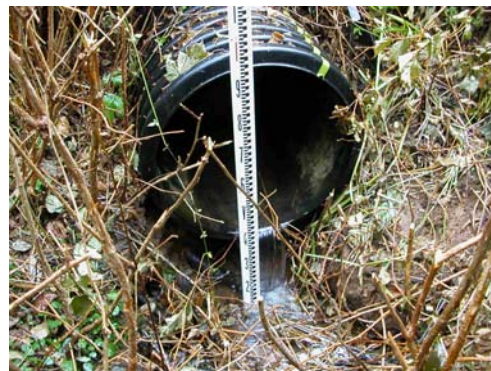
Review Date: 11/10/2003  
Field Crew: Glore/Lutz  
Barrier: Yes  
Passability (%): 33  
Method: LA  
Repair Status: UD  
Problem: outfall drop, slope

Toe measurement unavailable due to wetland influence.

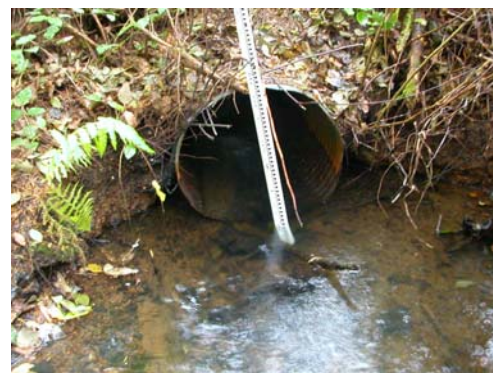
Review Date:	11/10/2003
Field Crew:	Glore/Lutz
Barrier	Yes
Passability (%)	33
Method	LA
Repair Status	UD
Problem	slope

Toe unavailable due to wetland influence.

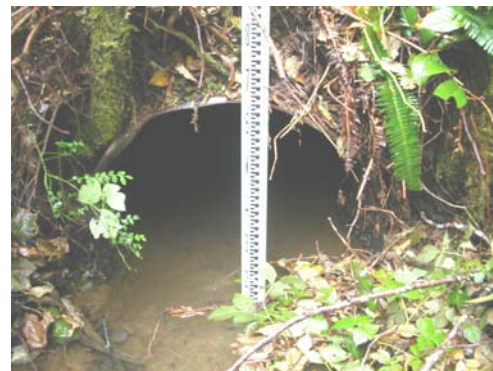
Review Date: 11/10/2003  
Field Crew: Glore/Lutz  
Barrier: Yes  
Passability (%): 67  
Method: LA  
Repair Status: UD  
Problem: slope

Toe unavailable due to braiding and wetland influence downstream. Upstream end of pipe is deformed.

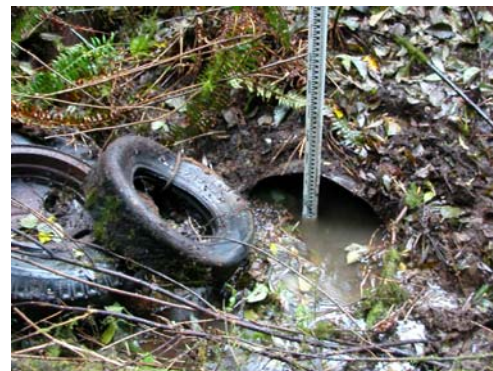
Review Date: 11/17/2003  
Field Crew: Glore/Lutz  
Barrier: Yes  
Passability (%): 67  
Method: LB  
Repair Status: UD  
Problem: velocity

Sequencer: 1.1  
Shape: RND  
Material: CST  
Span (m): 0.63  
Rise (m): 0.64  
Length (m): 14.67  
Slope (%): 1.50  
Bed Material: Yes  
Outfall Drop (m): 0.00  
WDIC (m): 0.18  
Apron: No  
Fill Depth (m): 3.00  
Tidegate: No

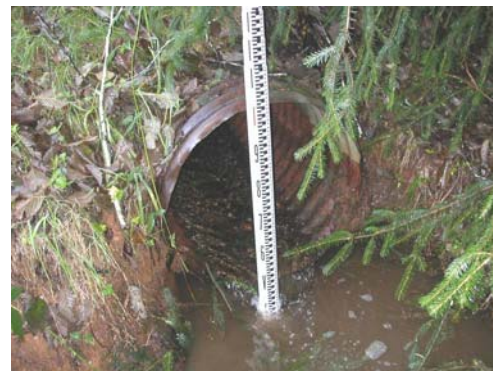
Review Date: 11/24/2003  
Field Crew: Gloire/Lutz  
Barrier: Yes  
Passability (%): 67  
Method: LA  
Repair Status: UD  
Problem: slope

Sequencer: 1.1  
Shape: RND  
Material: CST  
Span (m): 0.60  
Rise (m): 0.61  
Length (m): 13.67  
Slope (%): 4.50  
Bed Material: No  
Outfall Drop (m): 0.06  
WDIC (m): 0.07  
Apron: No  
Fill Depth (m): 2.20  
Tidegate: No

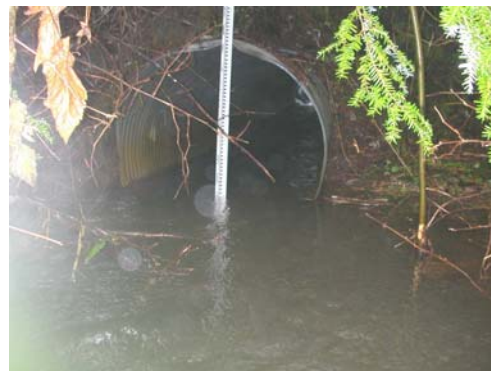
Review Date:	11/24/2003
Field Crew:	Glore/Lutz
Barrier	Yes
Passability (%)	33
Method	LA
Repair Status	UD
Problem	slope

WF Hoquiam 15 meters downstream of pipe. Wooden structure around the upstream end of culvert.

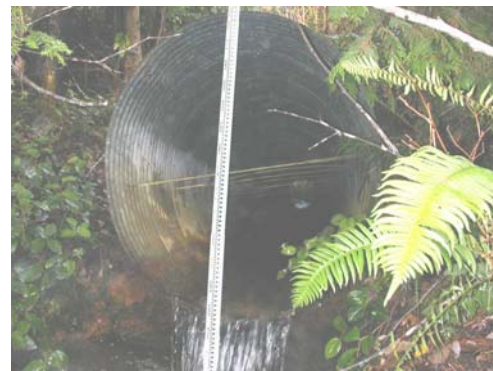
Review Date: 11/24/2003  
Field Crew: Glore/Lutz  
Barrier: Yes  
Passability (%): 33  
Method: LA  
Repair Status: UD  
Problem: outfall drop, slope

Braiding immediately downstream of pipe.  
Cables spanning interior of pipe at 0.6 meter intervals.

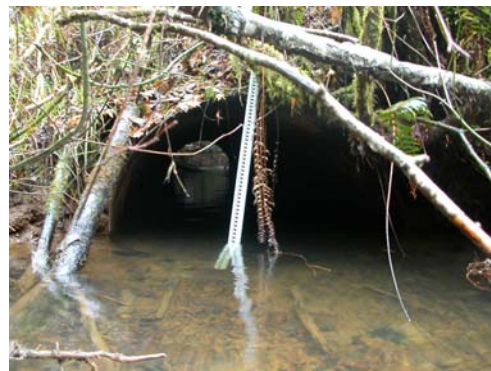
Wooden 2x4 frame constructed around upstream end of pipe.

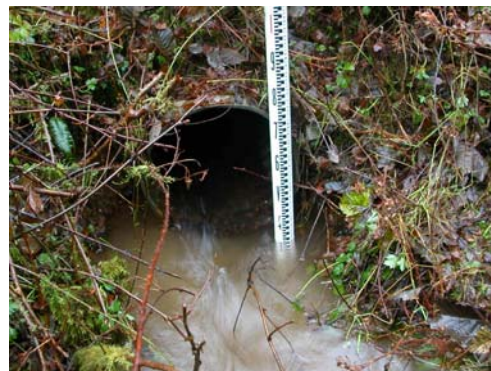
Review Date: 12/11/2003  
Field Crew: Glore/Lutz  
Barrier: Yes  
Passability (%): 67  
Method: LA  
Repair Status: UD  
Problem: slope

Cascade 3 meters downstream of the pipe measuring 0.8 meters high.

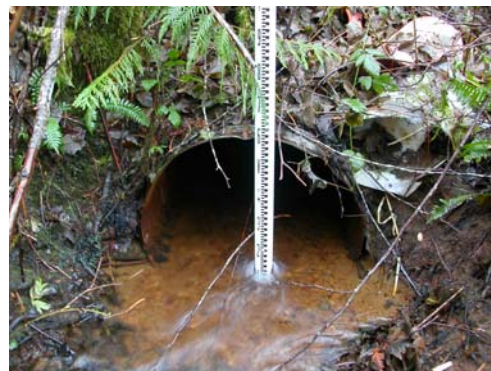
Review Date: 12/11/2003  
Field Crew: Glore/Lutz  
Barrier: Yes  
Passability (%): 67  
Method: LA  
Repair Status: UD  
Problem: slope

Lots of garbage is channel. No plunge pool as stream flows directly into riffles downstream of the pipe.

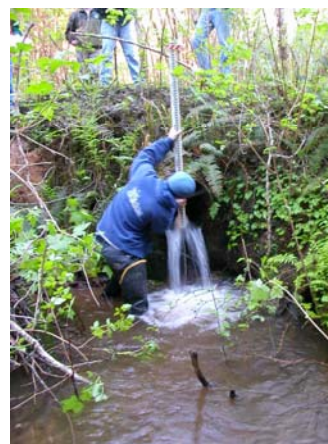
Review Date: 4/13/2004  
Field Crew: Glore/Blatt  
Barrier: Yes  
Passability (%): 33  
Method: LA  
Repair Status: UD  
Problem: outfall drop, slope

Downstream end of road is eroding.

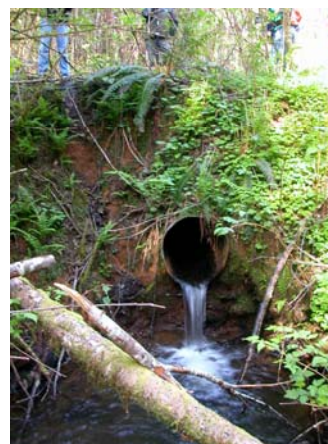
Review Date:	4/13/2004
Field Crew:	Glore/Blatt
Barrier	Yes
Passability (%)	33
Method	LA
Repair Status	UD
Problem	outfall drop, slope

Upstream end of culvert is deformed horizontally. Bank erosion present downstream of site.

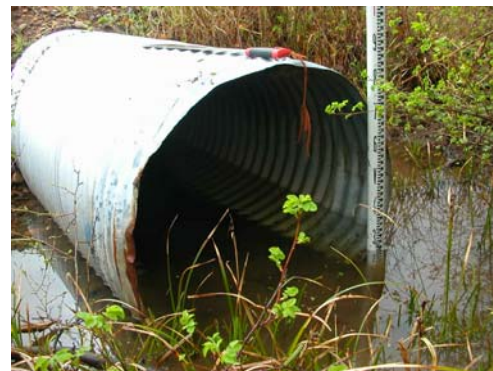
No plunge pool or stream width measurements due to wetland influence.

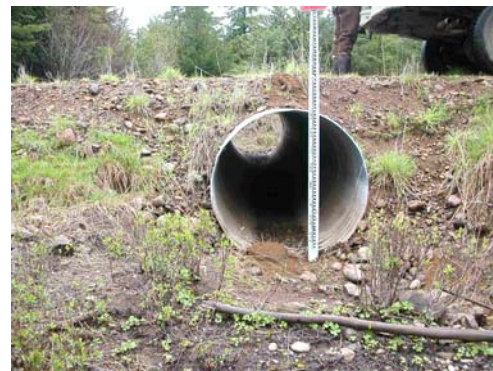
Review Date: 4/20/2004  
Field Crew: Glore/Blatt  
Barrier:  
Passability (%):  
Method:  
Repair Status:  
Problem:

Sequencer: 1.1  
Shape: RND  
Material: CST  
Span (m): 0.92  
Rise (m): 0.92  
Length (m):  
Slope (%):  
Bed Material: No  
Outfall Drop (m): 0.00  
WDIC (m): 0.00  
Apron: No  
Fill Depth (m): 1.00  
Tidegate: No

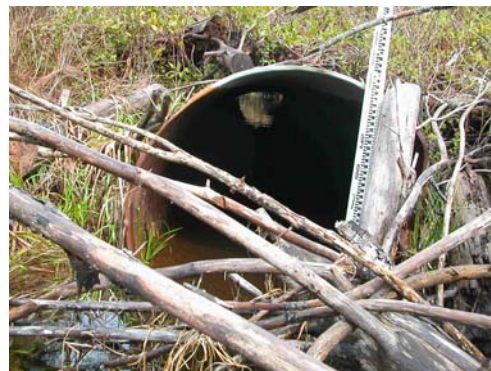
Review Date: 4/20/2004  
Field Crew: Glore/Blatt  
Barrier: Unk  
Passability (%):  
Method: LBNA  
Repair Status:  
Problem:

Plunge pool and stream width measurements unavailable due to wetland influence. Level B not applicable due to lack of downstream control.

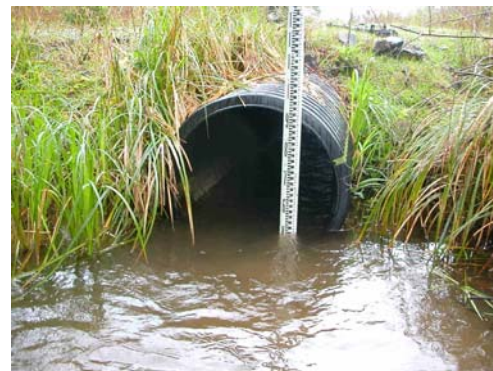
Review Date: 4/20/2004  
Field Crew: Glore/Blatt  
Barrier: Yes  
Passability (%): 67  
Method: LA  
Repair Status: UD  
Problem: slope

Stream width and plunge pool measurements unavailable due to wetland influence.

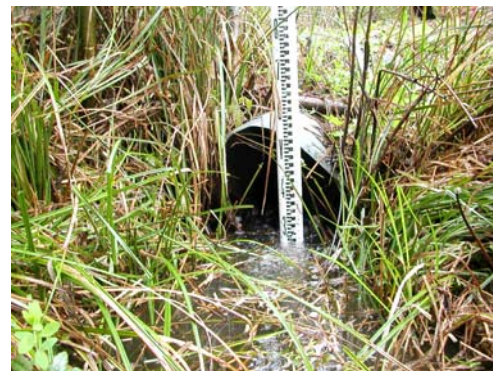
Review Date: 4/20/2004  
Field Crew: Glore/Blatt  
Barrier: Unk  
Passability (%):  
Method: LBNA  
Repair Status:  
Problem:

Plunge pool appears to be excavated. Level B not applicable due to lack of downstream control.

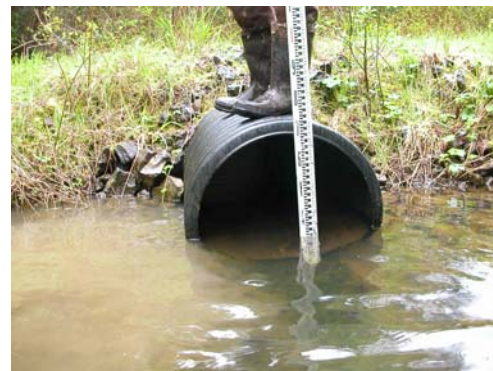
Review Date: 4/20/2004  
Field Crew: Glore/Blatt  
Barrier: Unk  
Passability (%):  
Method: LBNA  
Repair Status:  
Problem:

Stream width and plunge pool measurements unavailable due to wetland influence. Level B not applicable due to lack of downstream control.

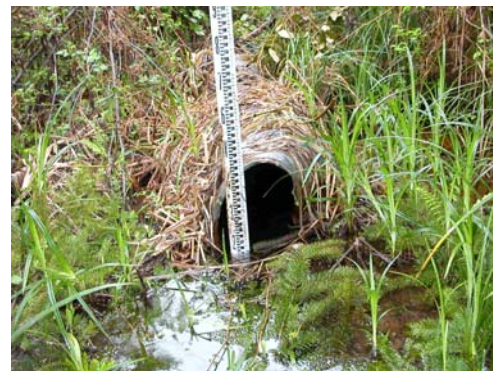
Review Date: 4/20/2004  
Field Crew: Glore/Blatt  
Barrier:  
Passability (%):  
Method:  
Repair Status:  
Problem:

Sequencer: 1.1  
Shape: RND  
Material: CST  
Span (m): 0.42  
Rise (m): 0.42  
Length (m):  
Slope (%):  
Bed Material: No  
Outfall Drop (m): 0.00  
WDIC (m): 0.05  
Apron: No  
Fill Depth (m): 1.50  
Tidegate: No

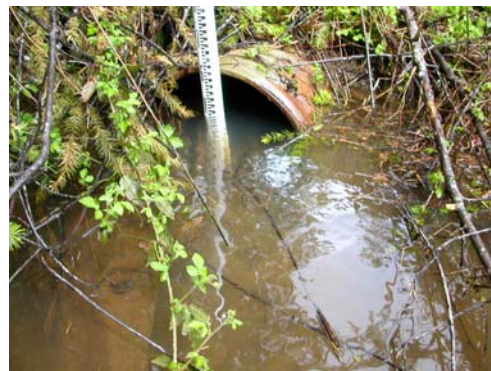
Review Date: 4/20/2004  
Field Crew: Glore/Blatt  
Barrier: Unk  
Passability (%):  
Method: LBNA  
Repair Status:  
Problem:

Wetland influence obscures stream width and plunge pool measurements. Level B not applicable due to lack of downstream control.

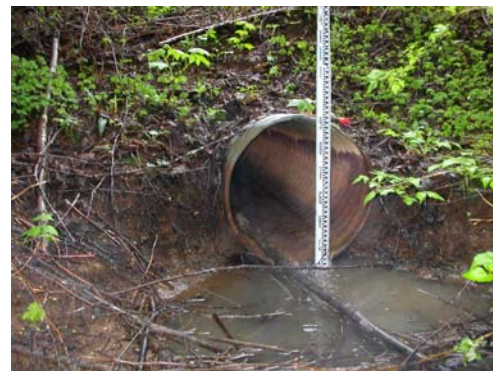
Review Date:	4/20/2004
Field Crew:	Glore/Blatt
Barrier	Yes
Passability (%)	67
Method	LA
Repair Status	UD
Problem	slope

Sequencer:	1.1
Shape	RND
Material	CST
Span (m)	0.62
Rise (m)	0.62
Length (m)	12.29
Slope (%)	1.84
Bed Material	No
Outfall Drop (m)	0.02
WDIC (m)	0.04
Apron	No
Fill Depth (m)	2.00
Tidegate	No

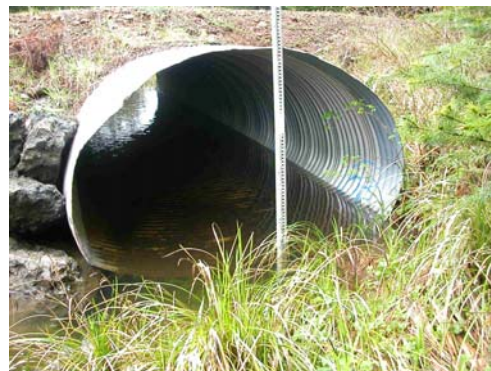
Site appears to be recent replacement. Toe and plunge pool unavailable due to wetland influence. Barrier status is unknown as toe is unavailable, although pipe appears to function adequately.

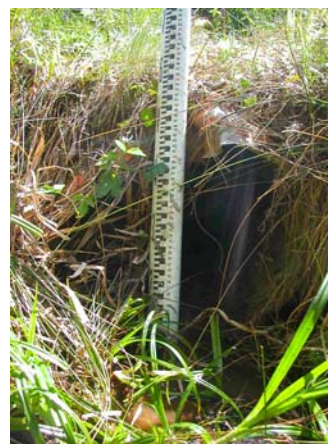
Review Date:	4/26/2004
Field Crew:	Glore/Blatt/Schuetzler
Barrier	
Passability (%)	
Method	
Repair Status	
Problem

Sequencer:	1.1
Shape	RND
Material	CST
Span (m)	0.47
Rise (m)	0.36
Length (m)	
Slope (%)	
Bed Material	No
Outfall Drop (m)	0.00
WDIC (m)	0.01
Apron	No
Fill Depth (m)	1.00
Tidegate	No

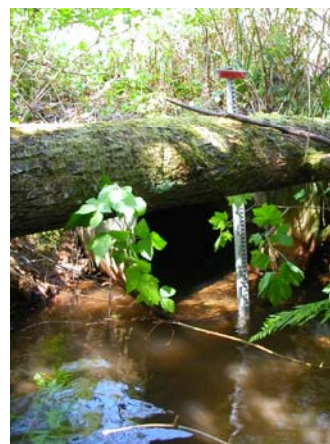
Review Date:	4/26/2004
Field Crew:	Glore/Blatt/Schuetzler
Barrier	Unk
Passability (%)	
Method	OT
Repair Status	
Problem

Need stream toe width to complete Level A sample.

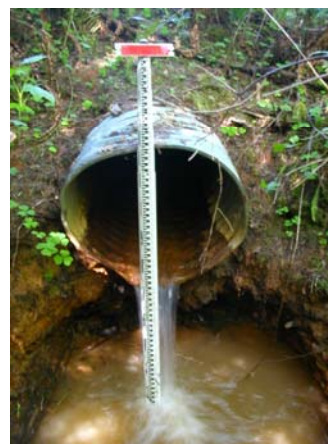
Review Date: 4/26/2004  
Field Crew: Glore/Blatt/Schuetzler  
Barrier:  
Passability (%):  
Method:  
Repair Status:  
Problem:

Sequencer: 1.1  
Shape: RND  
Material: CST  
Span (m): 0.67  
Rise (m): 0.58  
Length (m):  
Slope (%):  
Bed Material: No  
Outfall Drop (m): 0.45  
WDIC (m): 0.00  
Apron: No  
Fill Depth (m): 1.00  
Tidegate: No

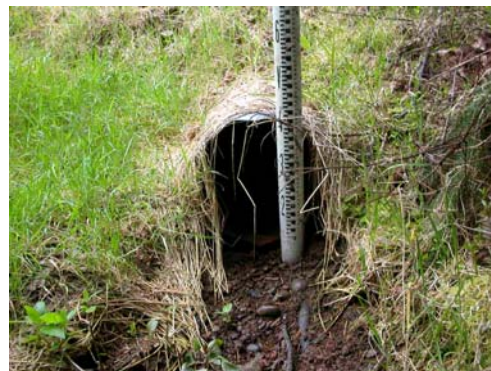
Review Date: 4/26/2004  
Field Crew: Glore/Blatt/Schuetzler  
Barrier:  
Passability (%):  
Method:  
Repair Status:  
Problem:

Sequencer: 1.1  
Shape: RND  
Material: CST  
Span (m): 0.34  
Rise (m): 0.34  
Length (m):  
Slope (%):  
Bed Material: No  
Outfall Drop (m): 0.00  
WDIC (m): 0.00  
Apron: No  
Fill Depth (m): 1.00  
Tidegate: No

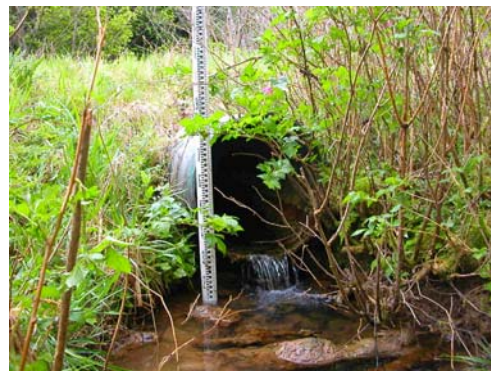
Review Date:	4/26/2004
Field Crew:	Glore/Blatt/Schuetzler
Barrier	No
Passability (%)	100
Method	LA
Repair Status	OK
Problem

Substrate predominantly fines and organic materials.

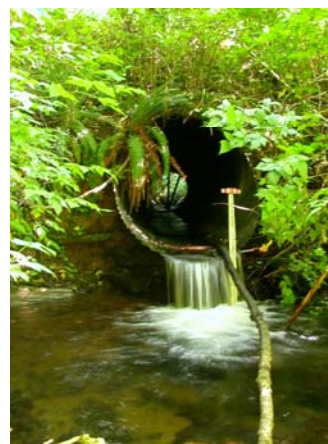
Review Date: 7/21/2004  
Field Crew: Glore/Blatt  
Barrier: Yes  
Passability (%): 33  
Method: LA  
Repair Status: UD  
Problem: outfall drop, slope

Both ends of pipe are beveled.

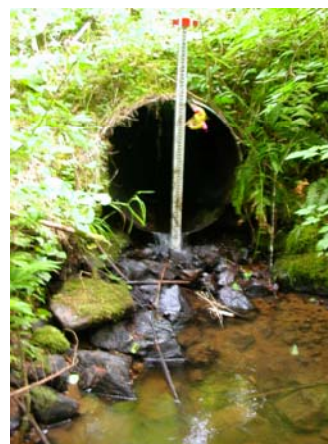
Review Date:	7/21/2004
Field Crew:	Glore/Blatt
Barrier	Yes
Passability (%)	33
Method	LA
Repair Status	UD
Problem	slope

Sequencer:	1.1
Shape	RND
Material	CST
Span (m)	0.93
Rise (m)	0.93
Length (m)	11.26
Slope (%)	3.66
Bed Material	No
Outfall Drop (m)	0.22
WDIC (m)	0.03
Apron	No
Fill Depth (m)	2.00
Tidegate	No

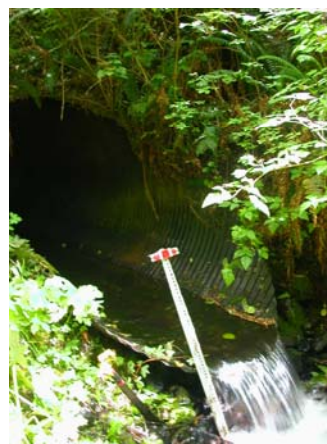
Review Date:	7/21/2004
Field Crew:	Glore/Blatt
Barrier	Yes
Passability (%)	67
Method	LA
Repair Status	UD
Problem	outfall drop

Both ends of pipe are beveled.

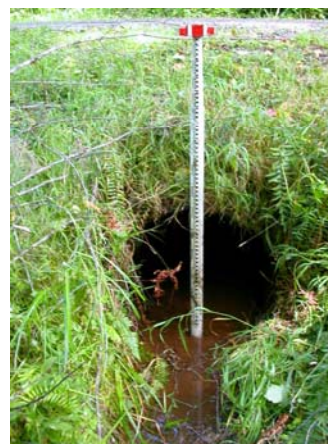
Review Date: 7/21/2004  
Field Crew: Glore/Blatt  
Barrier:  
Passability (%):  
Method:  
Repair Status:  
Problem:

Sequencer: 1.1  
Shape: RND  
Material: CST  
Span (m): 0.76  
Rise (m): 0.76  
Length (m):  
Slope (%):  
Bed Material: No  
Outfall Drop (m): 0.00  
WDIC (m): 0.03  
Apron: No  
Fill Depth (m): 1.00  
Tidegate: No

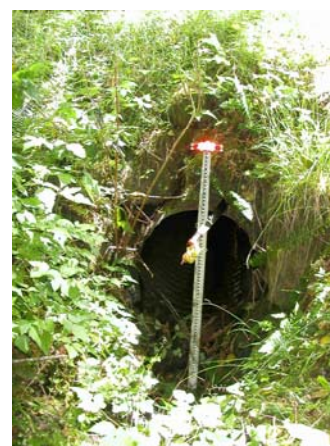
Review Date:	7/21/2004
Field Crew:	Glore/Blatt
Barrier	
Passability (%)	
Method	
Repair Status	
Problem

Upstream and downstream banks armored with rip-rap near site.

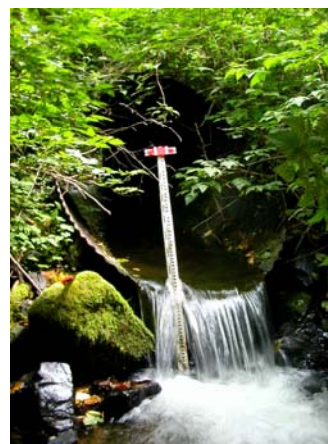
Review Date:	7/21/2004
Field Crew:	Glore/Blatt
Barrier	Yes
Passability (%)	33
Method	LA
Repair Status	UD
Problem	outfall drop, slope

Both ends of culvert are beveled.

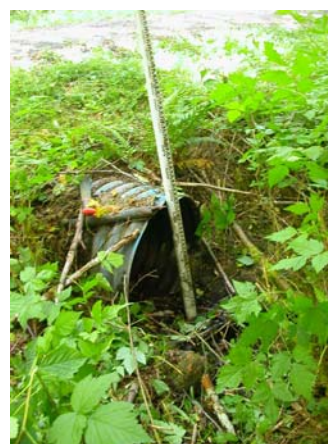
Review Date: 7/21/2004  
Field Crew: Glore/Blatt  
Barrier:  
Passability (%):  
Method:  
Repair Status:  
Problem:

Sequencer: 1.1  
Shape: RND  
Material: CST  
Span (m): 0.61  
Rise (m): 0.61  
Length (m):  
Slope (%):  
Bed Material: Unk  
Outfall Drop (m): 0.00  
WDIC (m): 0.01  
Apron: No  
Fill Depth (m): 0.25  
Tidegate: No

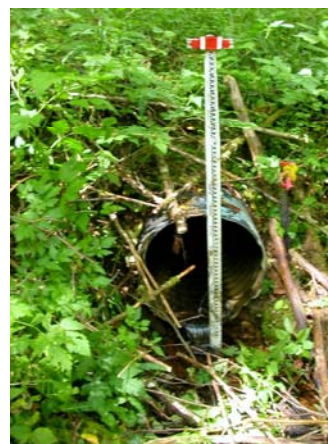
Review Date: 7/21/2004  
Field Crew: Glore/Blatt  
Barrier:  
Passability (%):  
Method:  
Repair Status:  
Problem:

No toe measurement due to ephemeral nature of stream.

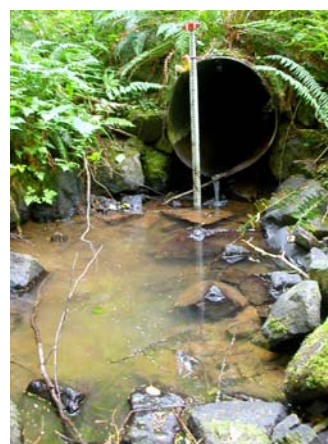
Plunge pool is man-made with rip-rap acting as downstream control. Culvert is up for replacement by City of Hoquiam - culvert # 7.

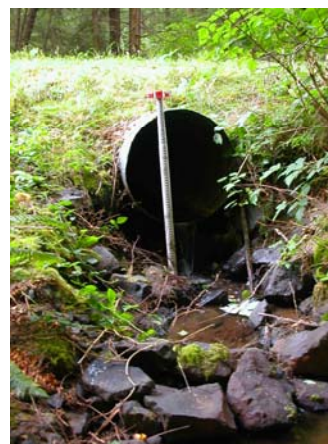
Culvert is up for replacement by City of Hoquiam, culvert # 8.

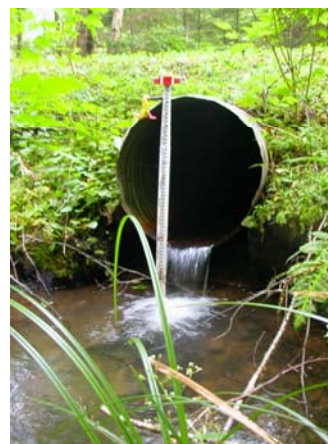
Plunge pool appears to be man-made with rip-rap acting as downstream control. Culvert is up for replacement by City of Hoquiam - culvert # 9.

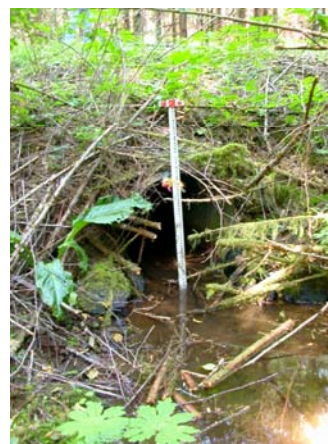
Review Date:	7/28/2004
Field Crew:	Glore/Blatt
Barrier	Yes
Passability (%)	67
Method	LA
Repair Status	UD
Problem	slope

Sequencer:	1.1
Shape	RND
Material	CST
Span (m)	0.91
Rise (m)	0.91
Length (m)	11.23
Slope (%)	3.12
Bed Material	No
Outfall Drop (m)	0.00
WDIC (m)	0.10
Apron	No
Fill Depth (m)	1.50
Tidegate	No

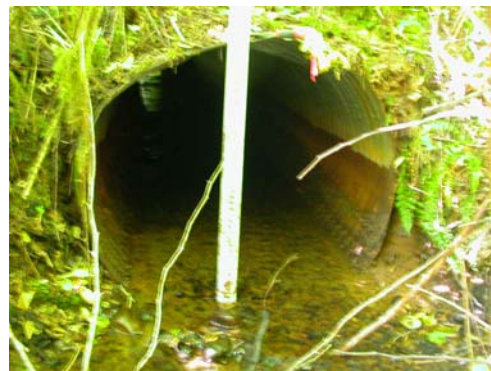
Review Date: 7/28/2004  
Field Crew: Glore/Blatt  
Barrier: No  
Passability (%): 100  
Method: LA  
Repair Status: OK  
Problem:

No plunge pool, riffle at downstream end of culvert.

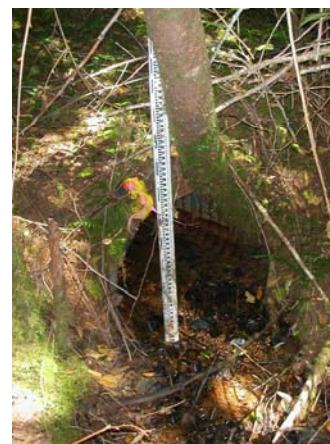
Review Date: 7/28/2004  
Field Crew: Glore/Blatt  
Barrier: No  
Passability (%): 100  
Method: LA  
Repair Status: OK  
Problem:

Sequencer: 1.1  
Shape: RND  
Material: CST  
Span (m): 0.76  
Rise (m): 0.76  
Length (m): 12.27  
Slope (%): 3.48  
Bed Material: Yes  
Outfall Drop (m): 0.00  
WDIC (m): 0.03  
Apron: No  
Fill Depth (m): 1.50  
Tidegate: No

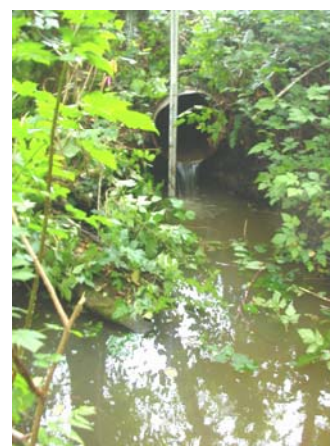
Review Date: 7/29/2004  
Field Crew: Glore/Blatt  
Barrier: Yes  
Passability (%): 33  
Method: LA  
Repair Status: UD  
Problem: outfall drop, slope

Additional pipe 15 meters downstream affects morphology, stream width measurements taken downstream of site 127Q0262. Fence posts act as debris gate.

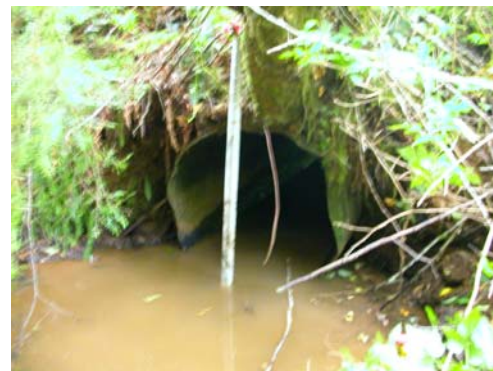
Review Date: 7/29/2004  
Field Crew: Glore/Blatt  
Barrier: Yes  
Passability (%): 67  
Method: LA  
Repair Status: UD  
Problem: slope

Tree growing over downstream end of pipe.

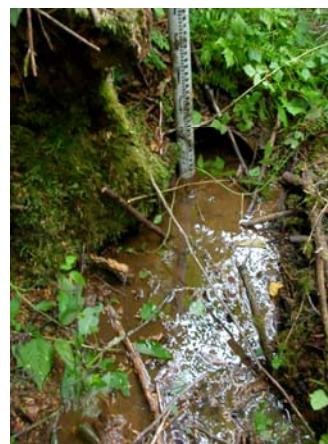
Review Date: 7/29/2004  
Field Crew: Glore/Blatt  
Barrier:  
Passability (%):  
Method:  
Repair Status:  
Problem:

Fine sediments fill 3/4 of downstream end of pipe.

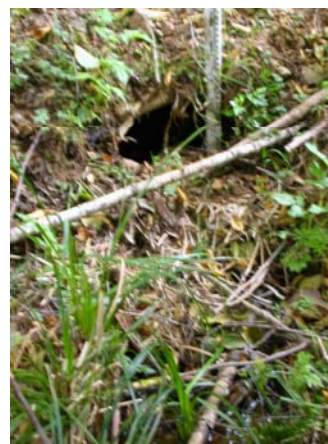
Review Date: 7/29/2004  
Field Crew: Glore/Blatt  
Barrier:  
Passability (%):  
Method:  
Repair Status:  
Problem:

Stream channel is choked with debris upstream and downstream. Picture taken at upstream end of culvert.

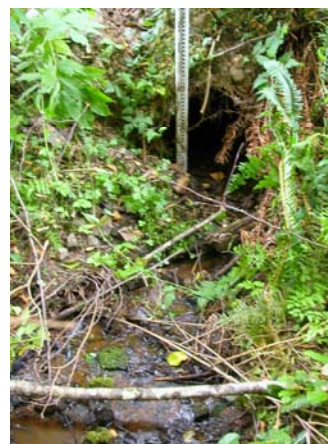
Review Date:	7/29/2004
Field Crew:	Glore/Blatt
Barrier	No
Passability (%)	100
Method	LA
Repair Status	OK
Problem

No plunge pool as stream riffles directly out of culvert.

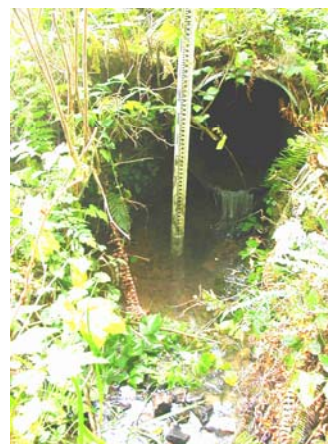
Review Date: 7/29/2004  
Field Crew: Glore/Blatt  
Barrier: Unk  
Passability (%):  
Method: LBRQ  
Repair Status:  
Problem:

Sequencer: 1.1  
Shape: RND  
Material: CST  
Span (m): 0.61  
Rise (m): 0.61  
Length (m): 7.56  
Slope (%): -0.97  
Bed Material: No  
Outfall Drop (m): 0.14  
WDIC (m): 0.02  
Apron: No  
Fill Depth (m): 1.00  
Tidegate: No

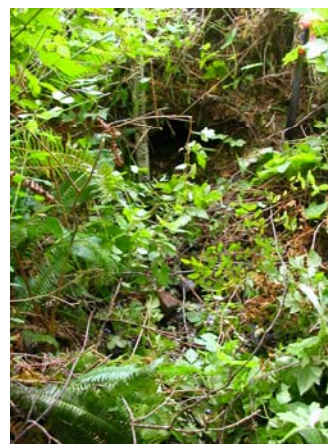
Review Date: 7/29/2004  
Field Crew: Glore/Blatt  
Barrier: Unk  
Passability (%):  
Method: LA  
Repair Status: UD  
Problem:

Upstream end of culvert is recessed under roadbed, inaccessible for length/slope shots.

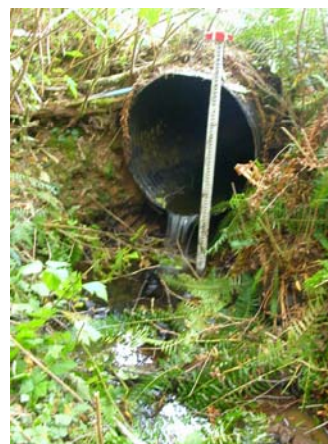
Review Date: 7/29/2004  
Field Crew: Glore/Blatt  
Barrier: Yes  
Passability (%): 33  
Method: LA  
Repair Status: UD  
Problem: outfall drop, slope

Plunge pool excavated and filled with rip-rap to prevent scour.

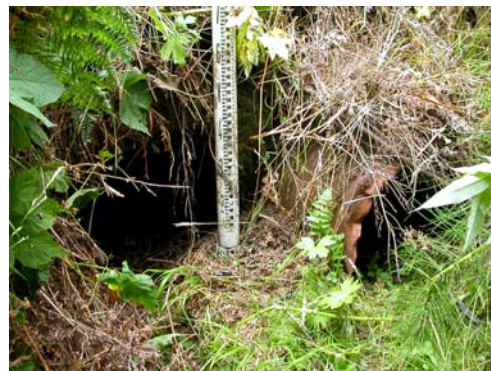
Review Date: 7/29/2004  
Field Crew: Glore/Blatt  
Barrier:  
Passability (%):  
Method:  
Repair Status:  
Problem:

Small overflow culvert on right bank. Picture taken at upstream end of pipe.

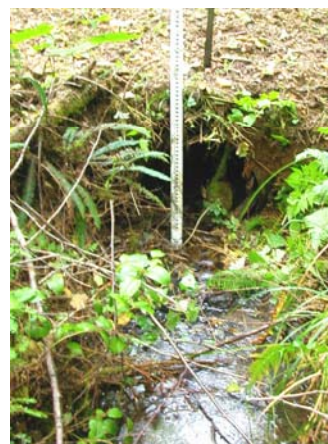
Review Date:	7/29/2004
Field Crew:	Glore/Blatt
Barrier	Yes
Passability (%)	67
Method	LA
Repair Status	UD
Problem	slope

Additional pipe on left bank upstream with no outlet located.

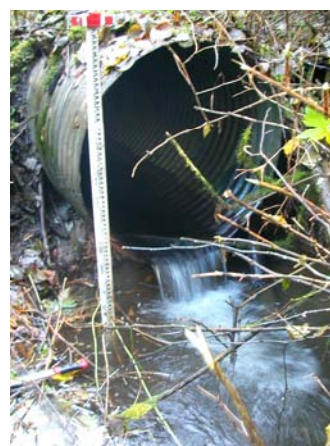
Review Date:	10/21/2004
Field Crew:	Glore/Blatt
Barrier	Yes
Passability (%)	33
Method	LA
Repair Status	UD
Problem	slope

Sequencer:	1.1
Shape	RND
Material	CST
Span (m)	1.08
Rise (m)	1.08
Length (m)	12.22
Slope (%)	3.27
Bed Material	No
Outfall Drop (m)	0.18
WDIC (m)	0.04
Apron	No
Fill Depth (m)	0.50
Tidegate	No

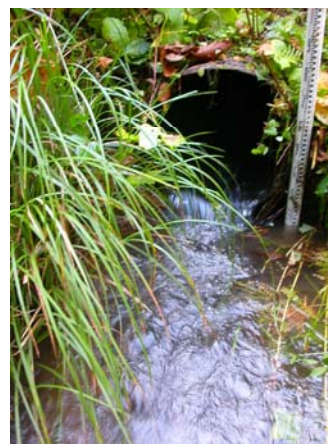
Review Date: 10/21/2004  
Field Crew: Gloire/Blatt  
Barrier: Unk  
Passability (%):  
Method: LBNA  
Repair Status:  
Problem:

Level B not applicable due to lack of downstream control.
