# **Hoquiam Drainage - Barrier Inventory Results**

# WRIA 22 Fish Passage Inventory

Mason Conservation District

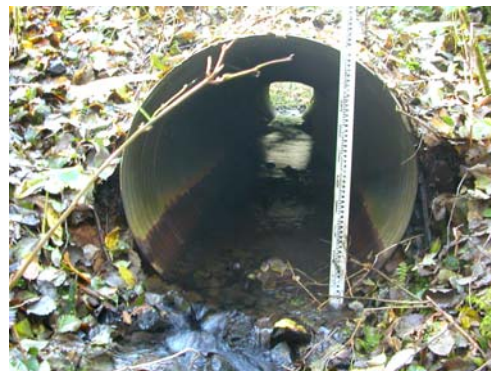
Review Date: 10/21/2004  
Field Crew: Glore/Blatt  
Barrier: No  
Passability (%): 100  
Method: LA  
Repair Status: OK  
Problem:

Slight grade break in culvert.

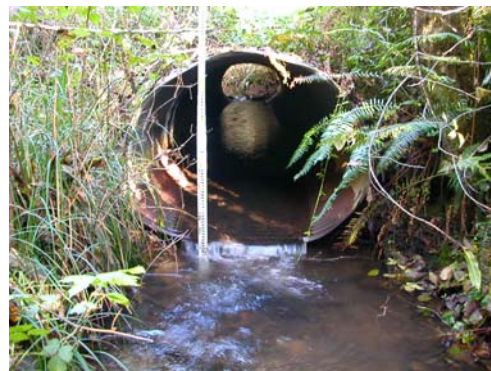
Review Date: 10/21/2004  
Field Crew: Glore/Blatt  
Barrier: No  
Passability (%): 100  
Method: LB  
Repair Status: OK  
Problem:

Level B completed on 12/15/05.

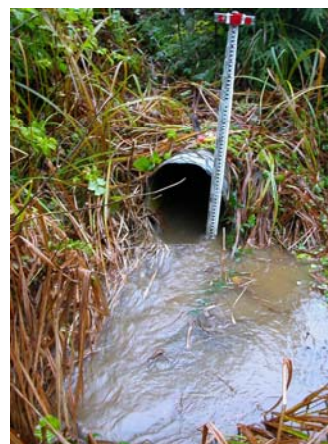
Review Date:	11/2/2004
Field Crew:	Glore/Blatt
Barrier	
Passability (%)	
Method	
Repair Status	
Problem

Sequencer:	1.1
Shape	RND
Material	CST
Span (m)	0.47
Rise (m)	0.47
Length (m)	
Slope (%)	
Bed Material	No
Outfall Drop (m)	0.10
WDIC (m)	0.08
Apron	No
Fill Depth (m)	1.00
Tidegate	No

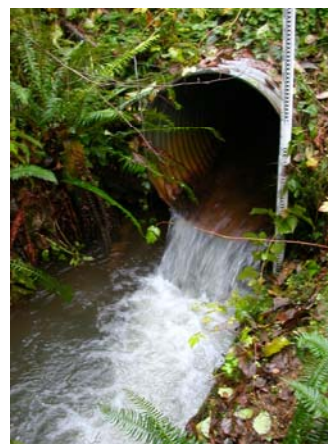
Review Date:	11/2/2004
Field Crew:	Glore/Blatt
Barrier	Yes
Passability (%)	33
Method	LA
Repair Status	UD
Problem	outfall drop

Logs on downstream end of culvert are confining plunge pool. Unable to obtain level A laser shots, upstream end of culvert is buried. Estimated slope =3% with clinometer.

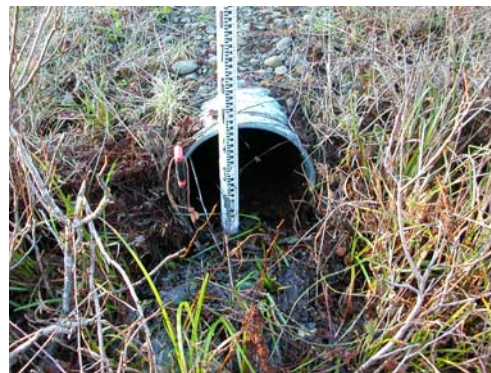
Review Date: 12/22/2004  
Field Crew: Glore/Blatt  
Barrier: Yes  
Passability (%): 67  
Method: LA  
Repair Status: UD  
Problem: slope

Braided wetland upstream and downstream of culvert making OHW and plunge pool measurements unobtainable.

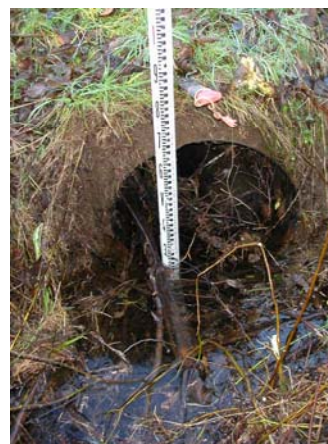
Measurements not obtainable due to wetland influences.

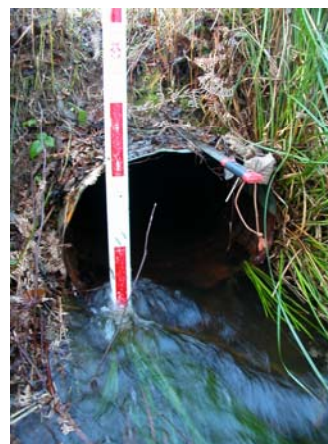
Review Date:	12/22/2004
Field Crew:	Glore/Blatt
Barrier	Yes
Passability (%)	67
Method	LA
Repair Status	UD
Problem	slope

Stream width and plunge pool measurements unobtainable due to wetland influences.

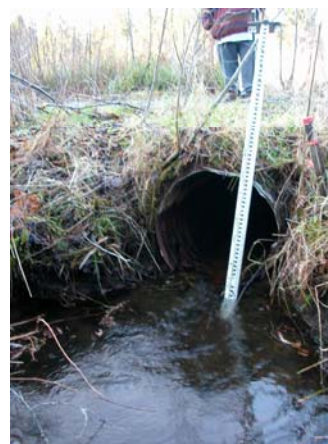
Review Date:	12/22/2004
Field Crew:	Glore/Blatt
Barrier	Unk
Passability (%)	
Method	LBNA
Repair Status	
Problem

Level B not applicable due to lack of downstream control.

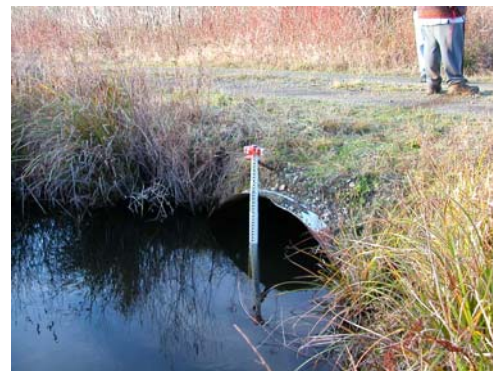
Review Date:	12/22/2004
Field Crew:	Glore/Blatt
Barrier	Yes
Passability (%)	67
Method	LA
Repair Status	UD
Problem	slope

Stream width and plunge pool measurements not obtainable due to wetland influences at site.

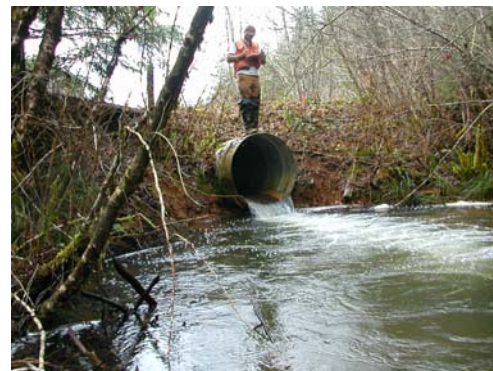
Review Date:	1/24/2005
Field Crew:	Glore/Blatt/Hamel
Barrier	Yes
Passability (%)	67
Method	LA
Repair Status	UD
Problem	outfall drop

Sequencer:	1.1
Shape	RND
Material	CAL
Span (m)	1.25
Rise (m)	1.25
Length (m)	8.95
Slope (%)	-0.30
Bed Material	No
Outfall Drop (m)	0.30
WDIC (m)	0.20
Apron	No
Fill Depth (m)	1.50
Tidegate	No

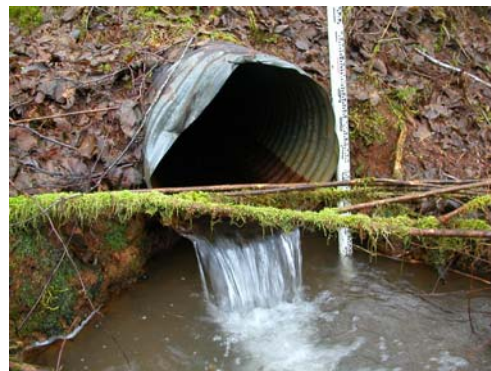
Review Date:	1/24/2005
Field Crew:	Glore/Blatt/Hamel
Barrier	No
Passability (%)	100
Method	LB
Repair Status	OK
Problem

Level B completed on 1/25/05.

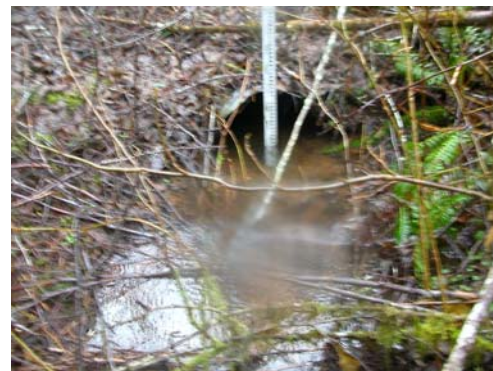
Review Date:	1/24/2005
Field Crew:	Glore/Hamel
Barrier	No
Passability (%)	100
Method	LA
Repair Status	OK
Problem

Debris pile at downstream end of culvert.

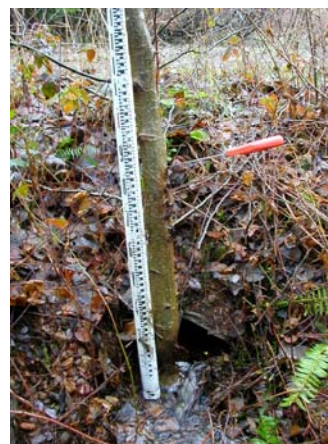
No measurable plunge pool.

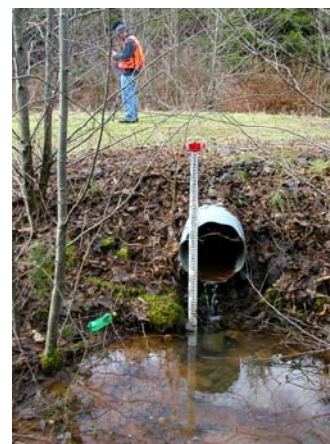
No stream width measurement due to poorly defined channel.

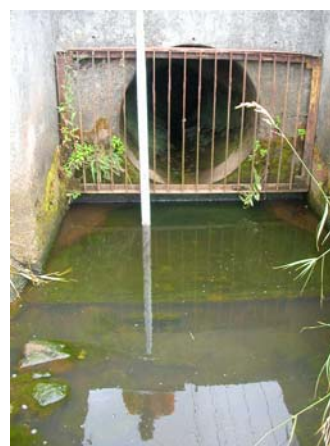
Sequencer:	1.1
Shape	RND
Material	SST
Span (m)	1.08
Rise (m)	1.08
Length (m)	
Slope (%)	
Bed Material	No
Outfall Drop (m)	0.05
WDIC (m)	0.00
Apron	DS
Fill Depth (m)	1.00
Tidegate	No

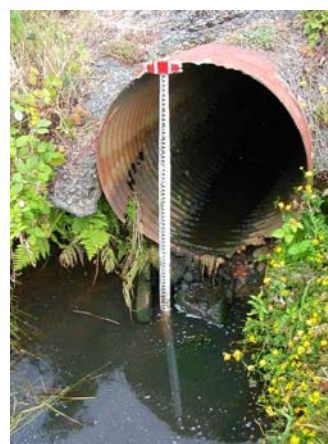
Sequencer:	1.1
Shape	RND
Material	CST
Span (m)	1.06
Rise (m)	1.06
Length (m)	
Slope (%)	
Bed Material	No
Outfall Drop (m)	0.22
WDIC (m)	0.01
Apron	No
Fill Depth (m)	1.00
Tidegate	No

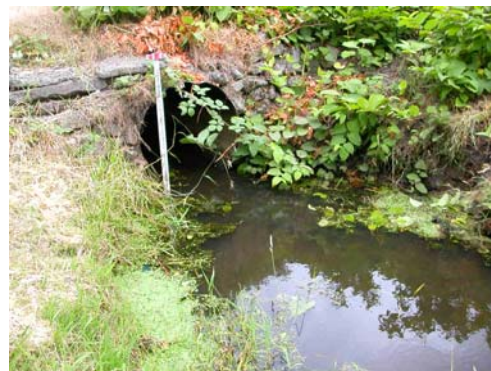
Sequencer:	1.1
Shape	RND
Material	CST
Span (m)	1.06
Rise (m)	1.06
Length (m)	
Slope (%)	
Bed Material	No
Outfall Drop (m)	0.00
WDIC (m)	0.10
Apron	No
Fill Depth (m)	1.00
Tidegate	No

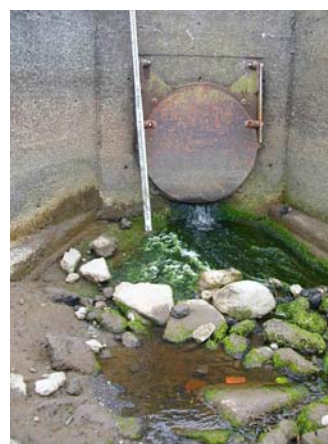
Sequencer:	1.1
Shape	RND
Material	CST
Span (m)	1.08
Rise (m)	1.08
Length (m)	
Slope (%)	
Bed Material	No
Outfall Drop (m)	0.20
WDIC (m)	0.02
Apron	No
Fill Depth (m)	1.00
Tidegate	Yes

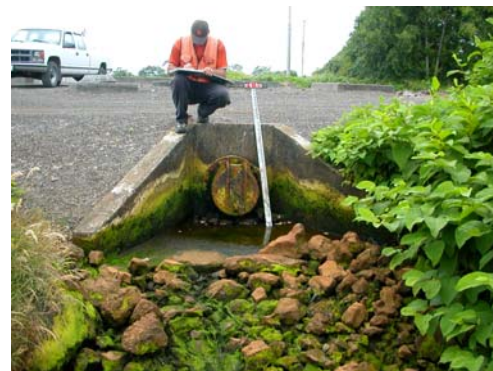
Rip rap pile at downstream end of apron.
