WRIA 22 Fish Passage Inventory

Mason Conservation District

127Y0389

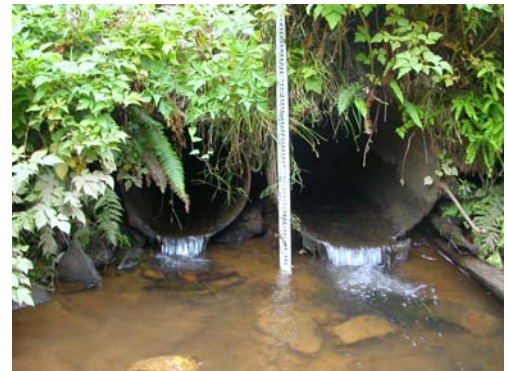
Surrounding land use is residential. Stream channel has been ditched and straightened. Single juvenal Coho observed at site.

Culvert 1.2 is located on LB.

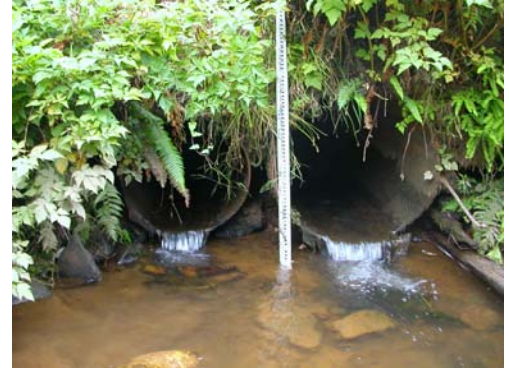
Site ID: 127Y0389

Sequencer:	2.2
Shape	RND
Material	CST
Span (m)	0.71
Rise (m)	0.71
Length (m)	7.82
Slope (%)	0.64
Bed Material	No
Outfall Drop (m)	0.08
WDIC (m)	0.03
Apron	No
Fill Depth (m)	0.75
Tidegate	No

Culvert 2.2 is located on RB.

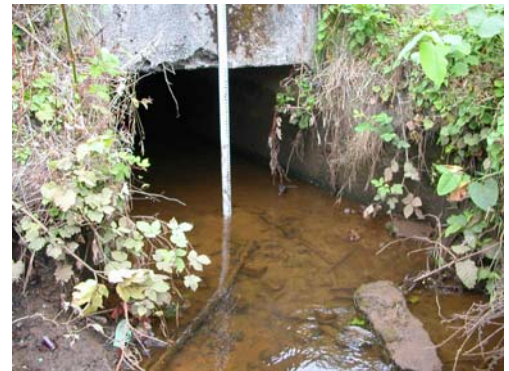
127Y0390

No plunge pool as stream riffles at DS end of culvert.

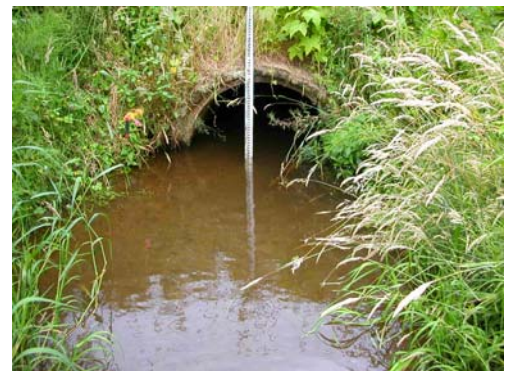
127Y0391

Stream width measurements affected by ditching of channel.

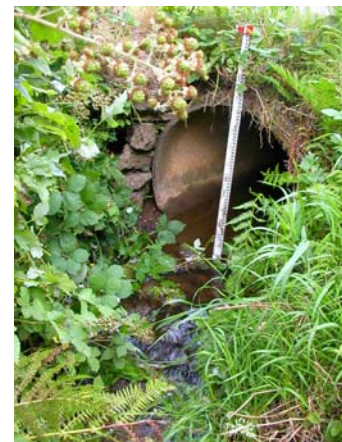
127Y0392

Cobble pile at DS end provides control point.

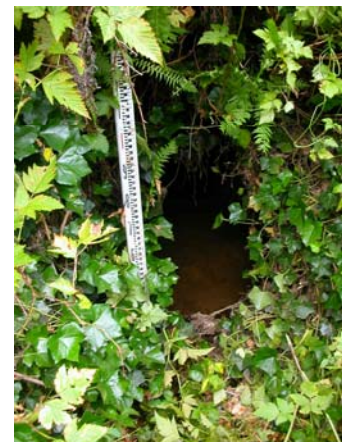
127Y0393

Landowner reports adult salmon returning in small numbers. Stream floods over road annually.

Review Date: 7/19/2004
Field Crew: Glore/Blatt
Barrier: Yes
Passability (%): 67
Method: LA
Repair Status: UD
Problem: Slope

No plunge pool measurements due to riffle at DS end of culvert. US end is beveled.

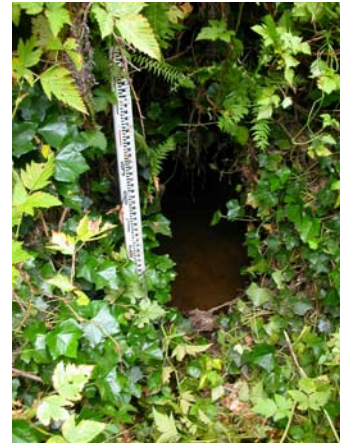
Site ID: 127Y0393

Sequencer:	2.2
Shape	RND
Material	CST
Span (m)	1.20
Rise (m)	1.20
Length (m)	18.47
Slope (%)	1.57
Bed Material	No
Outfall Drop (m)	0.00
WDIC (m)	0.00
Apron	No
Fill Depth (m)	1.00
Tidegate	No

Culvert 2.2 is located on RB.

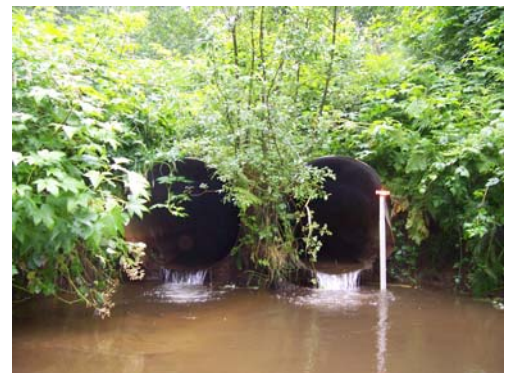
127Y0433

Review Date: 7/23/2007
Field Crew: Glore/Blatt
Barrier: Yes
Passability (%): 33
Method: LA
Repair Status: UD
Problem: slope; outfall drop

Pipe 1.2 is on left bank. Culvert is sloped inversely and rusted out at outlet. Mouth of culvert plugged with sediment and debris, only half of mouth is visible. Majority of water passes through pipe 1.2.

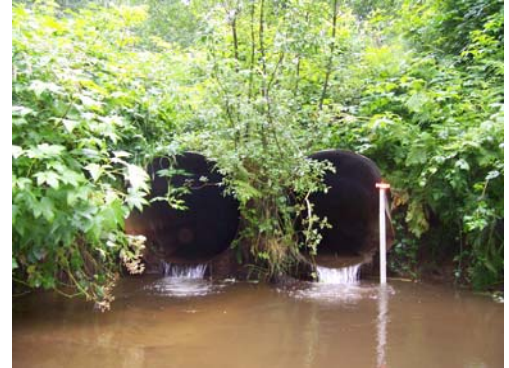
Site ID: 127Y0433

Sequencer:	2.2
Shape	RND
Material	CST
Span (m)	1.40
Rise (m)	1.40
Length (m)	21.08
Slope (%)	-3.90
Bed Material	No
Outfall Drop (m)	0.26
WDIC (m)	0.07
Apron	No
Fill Depth (m)	3.50
Tidegate	No

Pipe 2.2 is on right bank. Culvert is sloped inversely and rusted out at outlet. Mouth of culvert is submerged and almost completely clogged with sediment and debris.
